YANMAR AMERICA SERVICE ADVISORY

Advisory Number: YASA2011- 003 -M

SUBJECT: Heat Exchanger Miss-assembly

MODEL(S): 4JH4-TE, 4JH4-THE, 4JH4-HTE and 4JH3-DTE

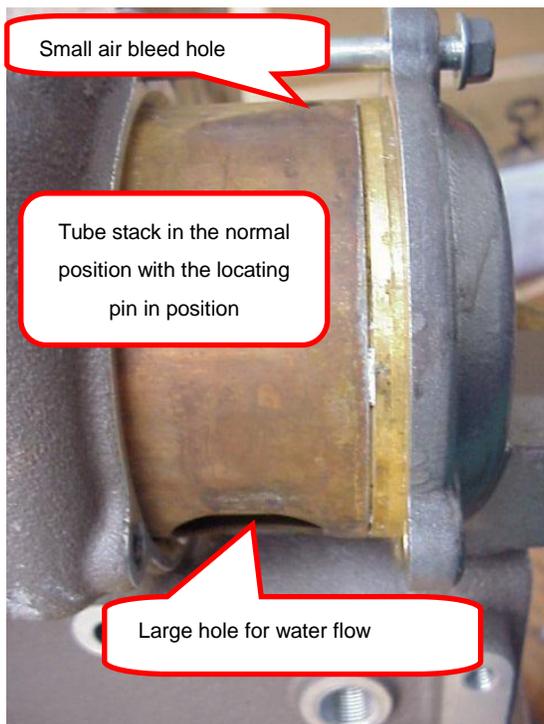
- a. Drain the fresh and raw waterside of the engine down into suitable containers and dispose of properly.
- b. Remove the inlet and out let caps from the heat exchanger
- c. Before removal, mark the core assembly and the heat exchanger with a line for reference.
- d. Slowly push the core assembly out of the housing in a straight line.
- e. Check and see if the air bleed hole is positioned at the top of the heat exchanger, see photo 1.

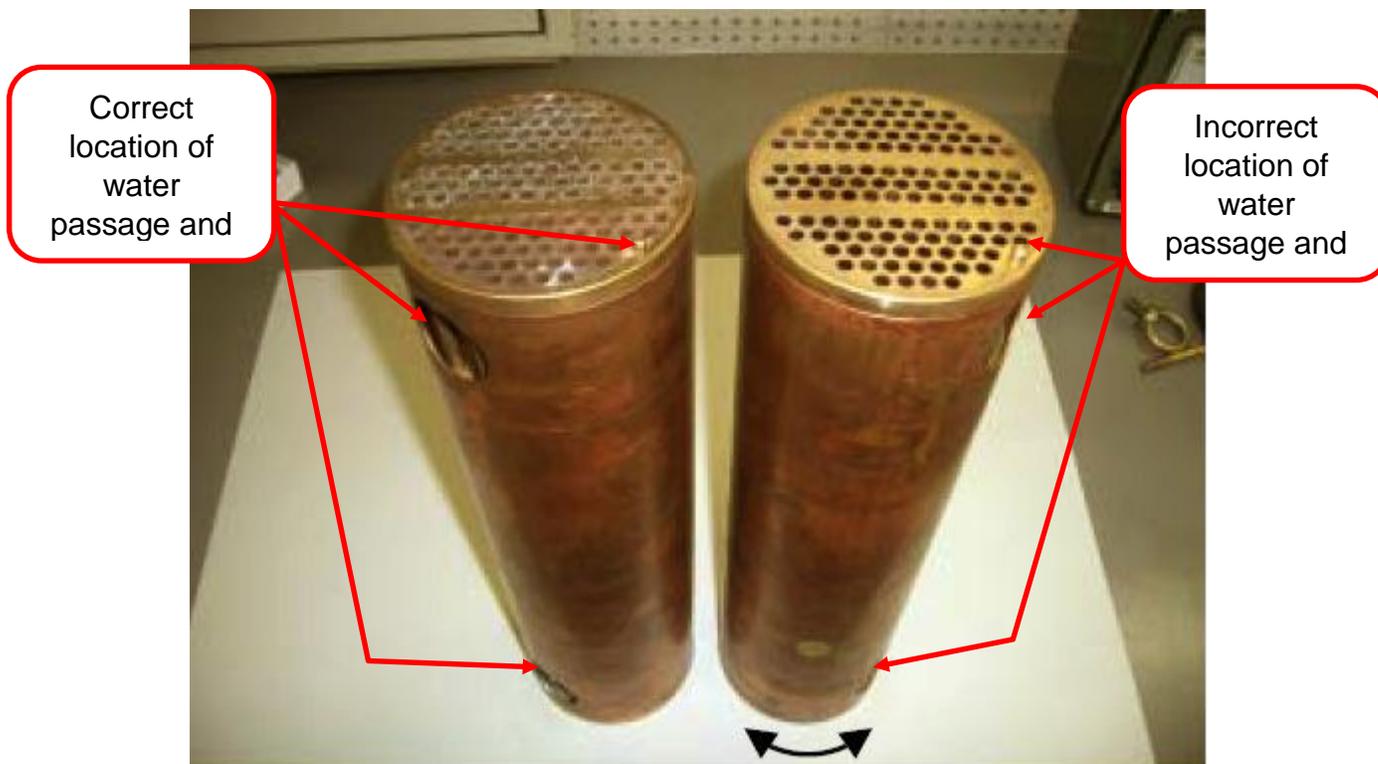
- f. Check the alignment between the outer copper housing and the tube stack, see photo 2. The core may turn on the tube stack.

- g. If the tube stack is not aligned properly or the outer housing turns on the tube stack please replace complete the complete heat exchanger assembly (129672-44900). The old parts need to be returned to Yanmar through standard warranty return procedures.
