1997 Jefferson 48 Rivanna Sundeck
WEGO

Report of Marine Survey

1997 Jefferson 48 Rivanna Sundeck

May 14, 2019

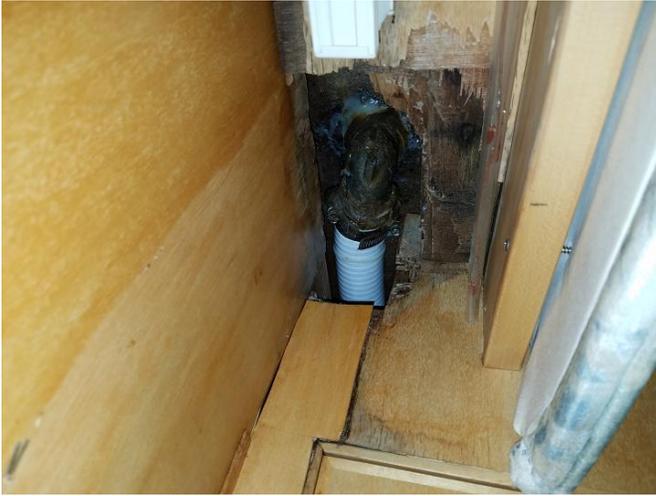
WATER INTRUSION SIGNS: Port and starboard salon aft stained/deteriorated flooring, master stateroom sole was soft below the wood flooring and propped up with a wedged in 4 x 4.

Looking up, starboard aft salon corner water damages from above

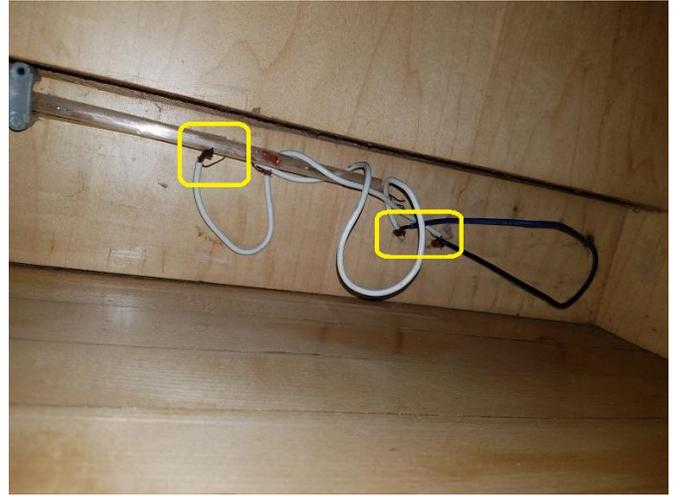
Starboard forward engine compartment lighting, DC, was inoperable. Headliner and aft deck light fixtures were missing lenses. Twisted connections noted for the rope lighting below the berth.

Rope lighting below berth, twisted wire connections

Investigate further and repair/renew as necessary.

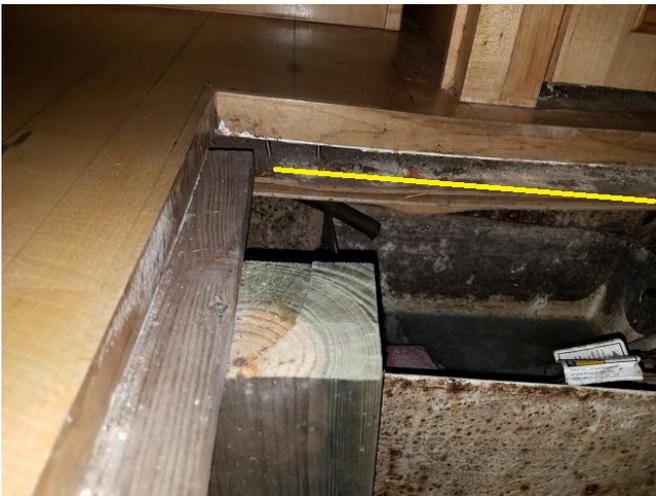
Master stateroom sole soft, supported by wedged 4 x 4

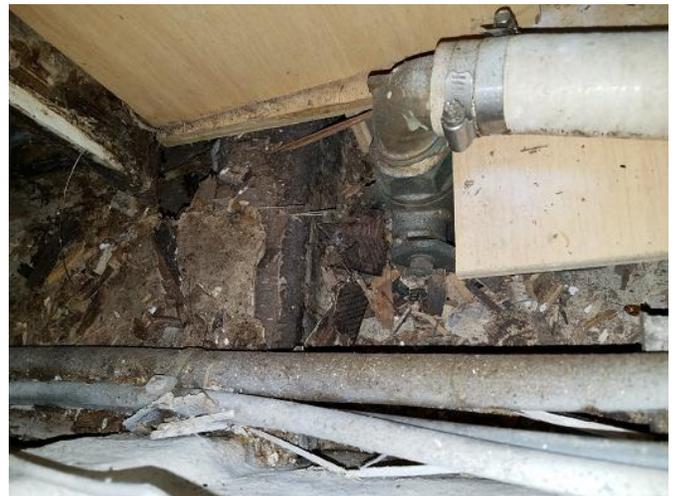
STORAGE AREAS: The cabinets, lockers, drawers, and shelving were sighted and found to be serviceable. Shelving in both the marine heads below the basins showed to be rotted/deteriorated.

Deteriorated shelf, inside aft marine head vanity

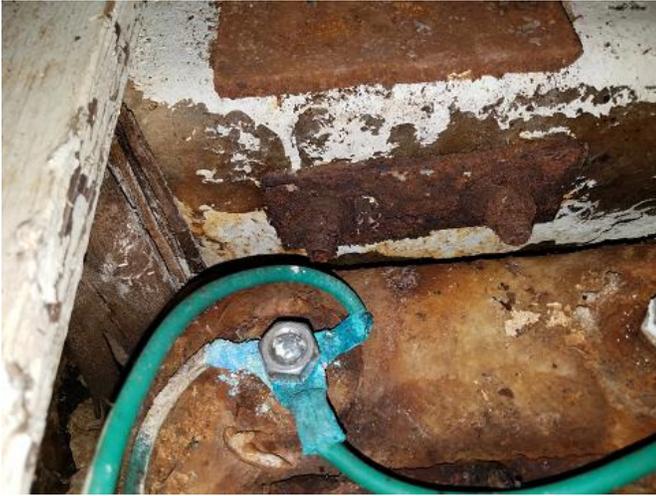
Heavy corrosion noted for most of the bonding wire connections in the aft bilge/rudder post area.

Heavy corrosion noted for most bonding wire connections

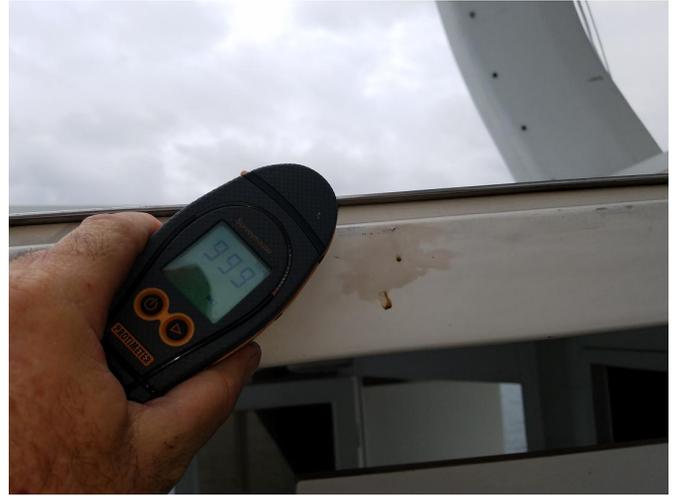
Water spots noted to be dripping out of the aft deck hard top overhead light fixtures. Moisture meter readings were pegged for the forward trim at the slide back top centerline.

Moisture meter pegged 999 (0-999) scale, slider for bridge / aft deck access

Investigate further and repair/reseal/renew as desired.

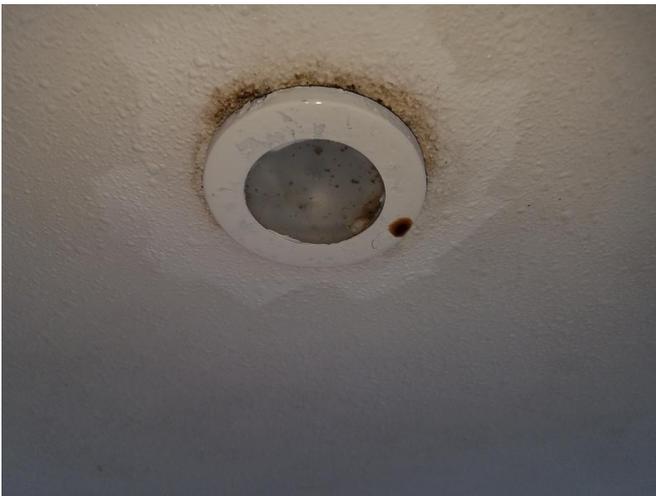
Moisture inside aft deck hardtop lighting

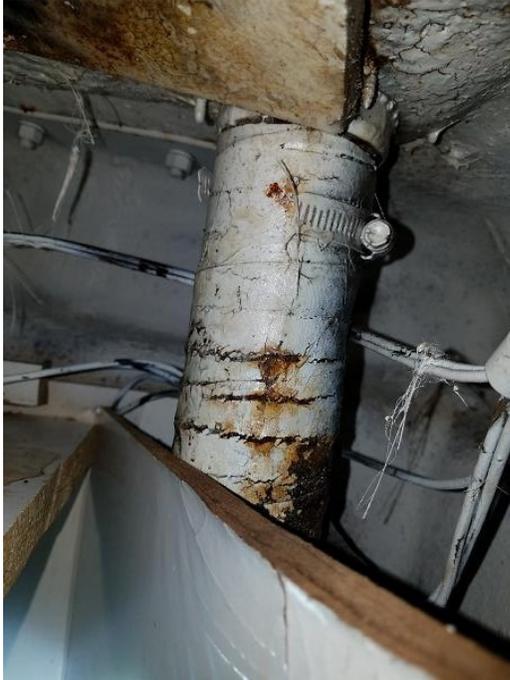
Deck drain hoses were noted to be showing age/jacket cracking throughout vessel, as observed engine compartment and aft in the master stateroom.

Age/jacket cracks for aft deck drain hose, port aft corner

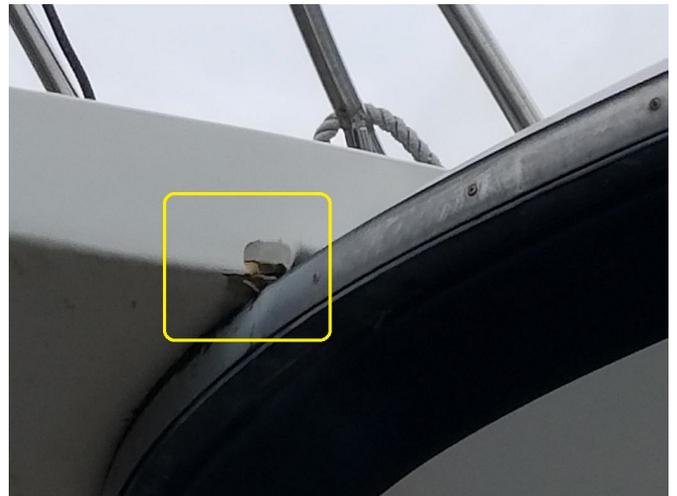
Pulpit was cracked/soft both port and starboard at the deck to pulpit joint. Water was dripping off of the fasteners in the chain locker overhead.

Cracked pulpit, port and starboard

Remove pulpit and obtain FRP repair, reseal/rebed all deck hardware as needed.

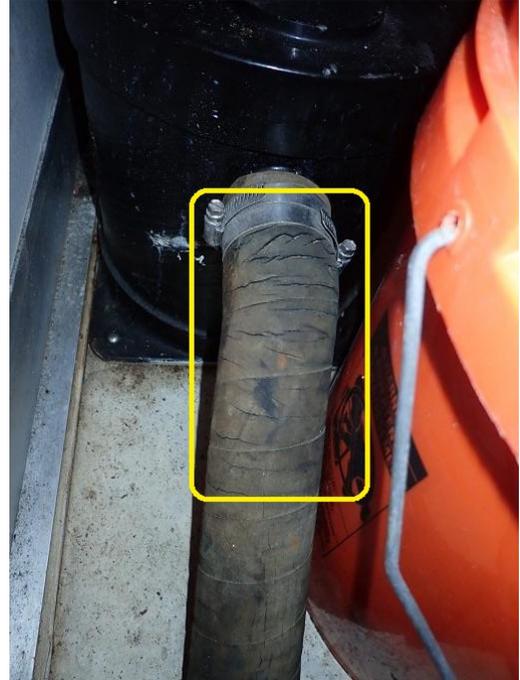
Generator exhaust hose age cracking at waterlift

B.15 (PAGE 9) EXHAUST SYSTEM: Generator's exhaust hose showed heavy cracking at the exhaust pot. The exhaust hose for the generator to have no support from waterlift pot to topsides fitting.	<i>Renew exhaust hose, support discharge hose to prevent pulling on discharge fitting.</i>
B.16 (PAGE 9) DC/AC INVERTER: The inverter's DC supply wiring was direct to 8D battery with no battery switch or inline overcurrent protection installed. Extension cords were draped across the engine compartment for the AC output side of inverter.	<i>Remove this installation. Should an inverter be desired, install out of engine compartment in a cool location. Provide grounding conductor for cabinet, inline overcurrent protection and on/off switching for DC supply. Route AC output wiring and support every 18", using 600V boat cable.</i>

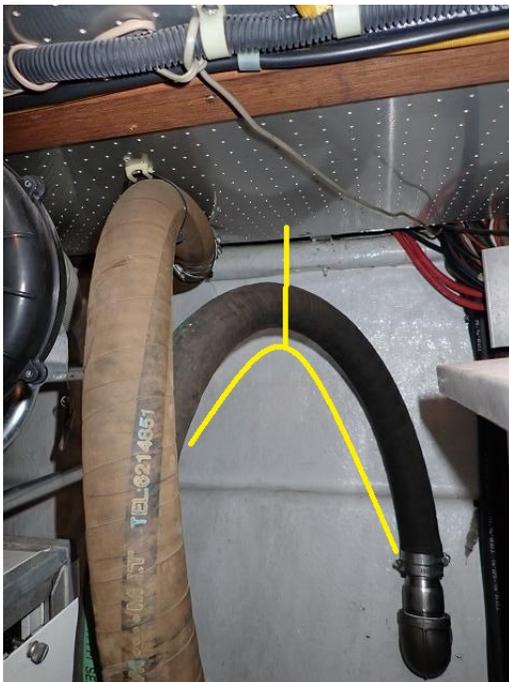
No support for generator exhaust hose

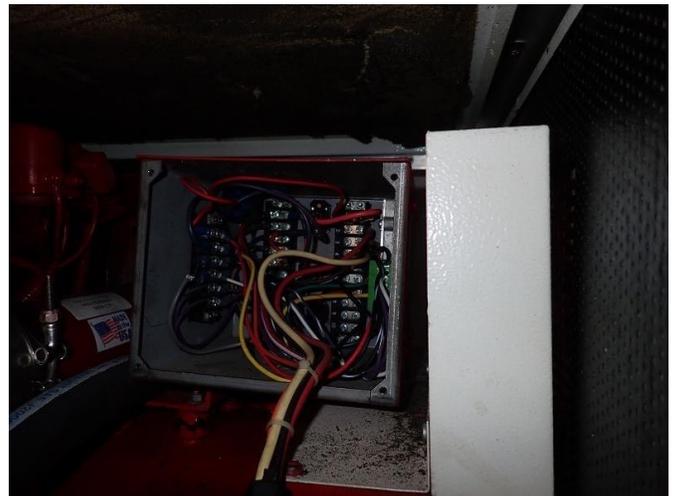
Exposed wiring connections, generator

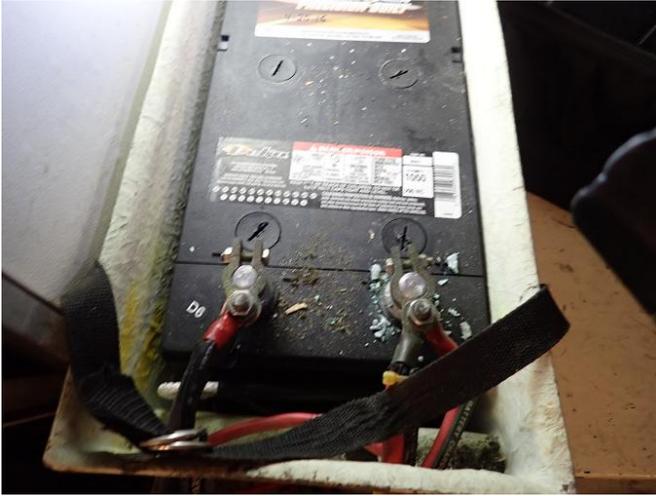
D6 (April 2016) date code for generator lead acid battery

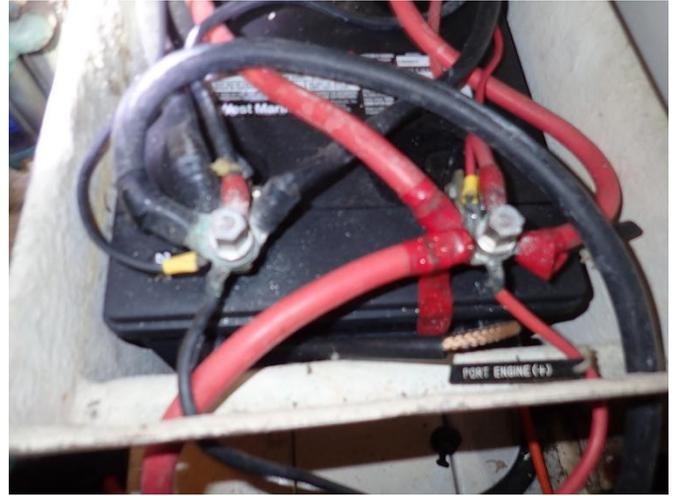
Excessive connections per terminal

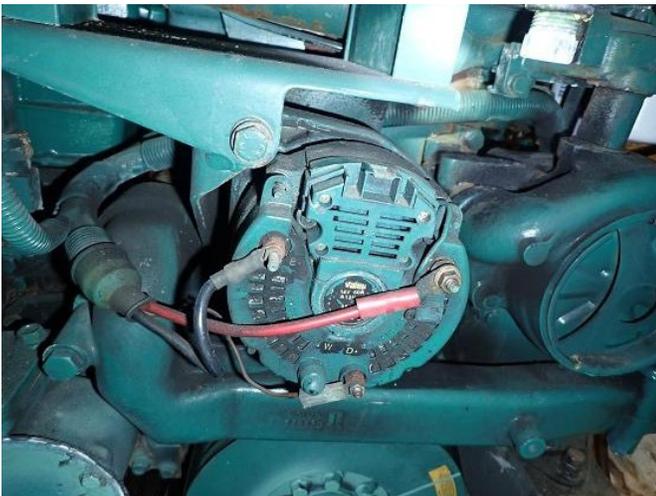
No covers on hot/ungrounded connections for alternators/starters

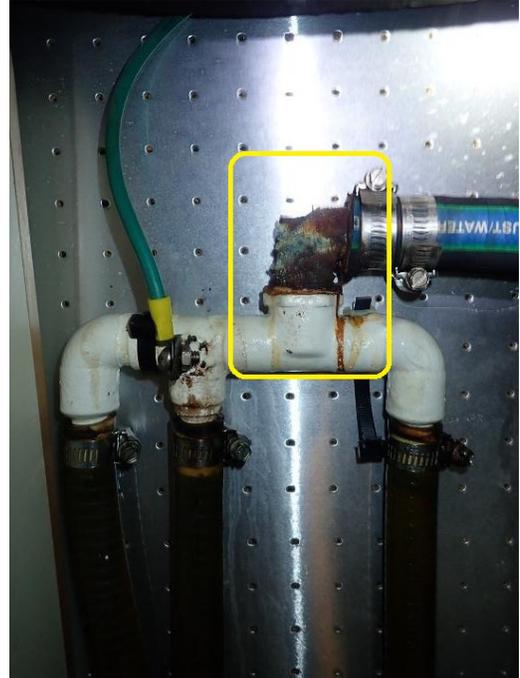
Corrosion/weepage, Air Conditioning raw water manifold

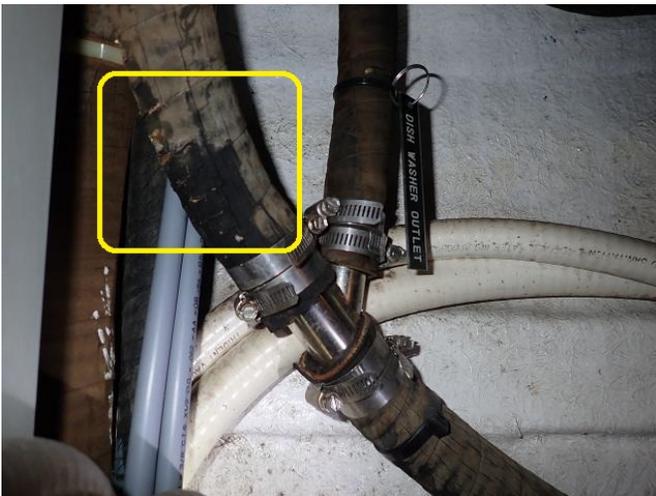
Age/jacket cracks, Stbd fwd engine compartment drain hoses

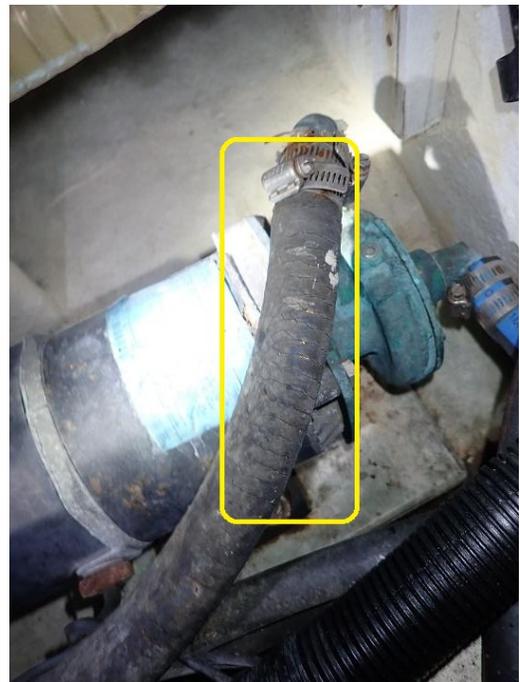
Raw water hose for air conditioning supply, from pump to manifold is dry with a cracked surface. Intake air filters on the air conditioning evaporators were dirty or non existent. Master stateroom unit showed a minimal drop down temperature differential.

Age/jacket cracks, Air conditioning raw water supply hose

Renew hose with marine grade reinforced hose, renew hose clamps with 100% marine grade stainless steel. Renew/clean AC filters. Investigate master stateroom unit further and repair as needed.

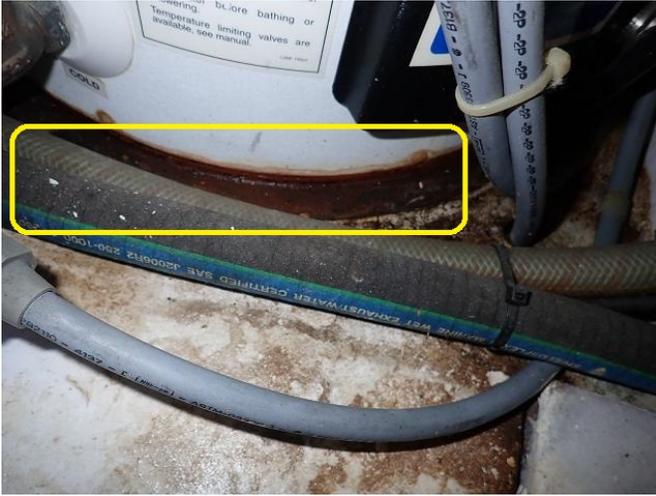
Corrosion and dampness noted at the base of water heater. Pressure relief valve is plumbed to the bilge.

Wet and rust noted base of water heater

Investigate further and repair as needed following a thorough cleaning and repair of generator leaks as well (water could be coming from elsewhere). Per ABYC standards, vessels with dockside water hook ups shall have the water heater's pressure relief valve plumbed overboard in case of discharge.

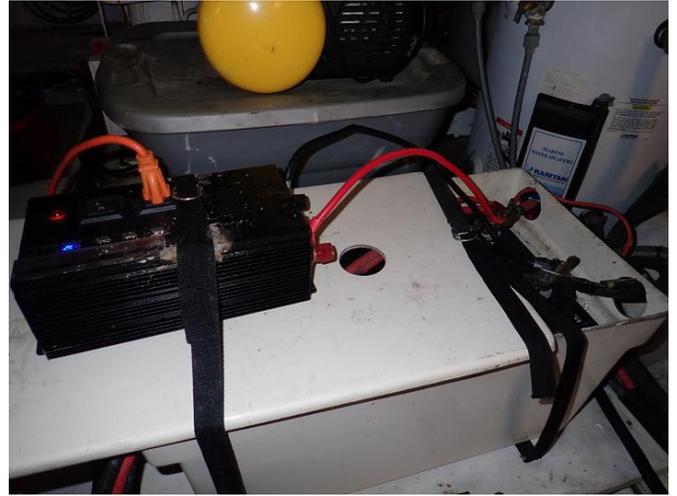
Inverter direct to battery, no over current protection, no grounding of cabinet, loose extension cords

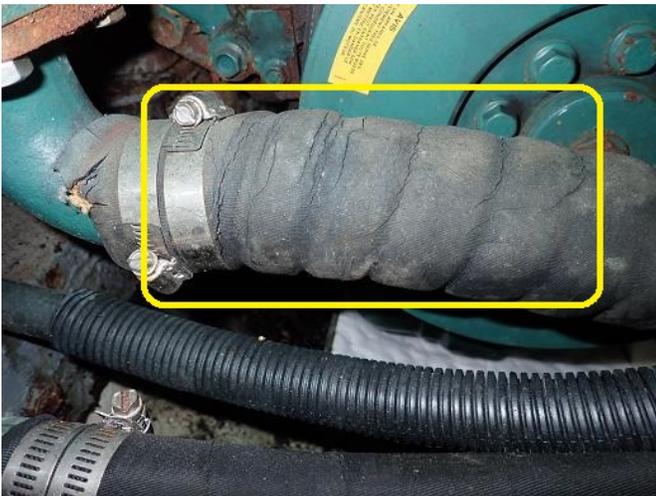
Engine raw water supply hose age/jacket cracks

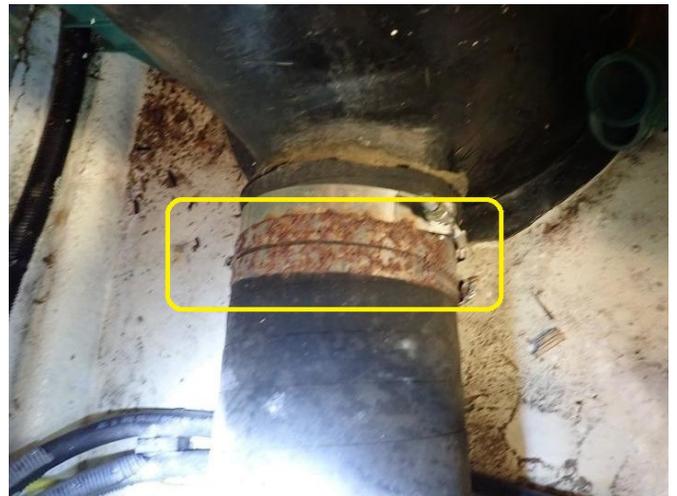
FINDINGS	RECOMMENDATIONS
B.8 (PAGE 7) EXHAUST SYSTEM: The engine exhaust hose clamps in the aft engine bilge area were showing rust/corrosion.	<i>Renew and double clamp with marine grade full stainless steel clamps.</i>
B.9 (PAGE 7) HOSES AND CLAMPS: Port and starboard engine raw water hoses at the seacocks were showing age/jacket cracking.	<i>Renew hoses and clamps, using reinforced marine hose and 100% marine grade stainless steel hose clamps.</i>
B.10 (PAGE 7) SEACOCKS AND STRAINERS: Port and starboard engine raw water intake seacocks would not operate with normal pressure.	<i>Service, repair, or renew as necessary all below the waterline thru hull valves to provide smooth/dependable operation.</i>
B.11 (PAGE 7) PACKING GLAND: Water injection hoses (port and starboard) for the packing gland lube/cooling water were noted to be showing age/jacket cracks at the exhaust risers.	<i>Renew hoses.</i>

Exhaust hose clamp corrosion, port aft

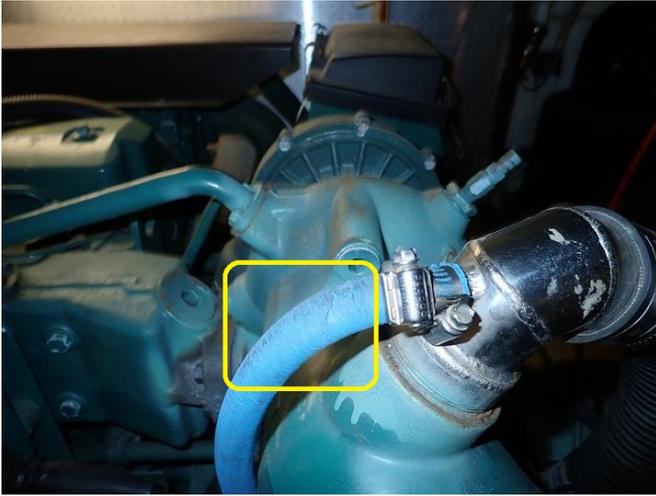
Water hoses for prop shaft glands, jacket cracking at risers, p/s

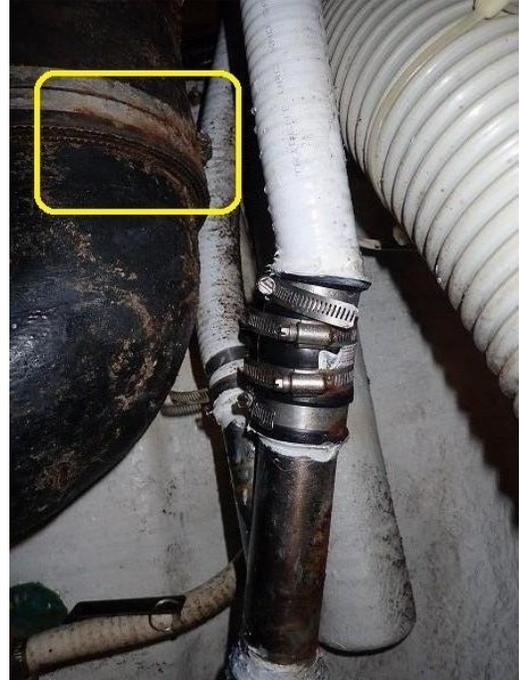
Drain assembly homemade/leaking, aft engine compartment note corroded exhaust hose clamps

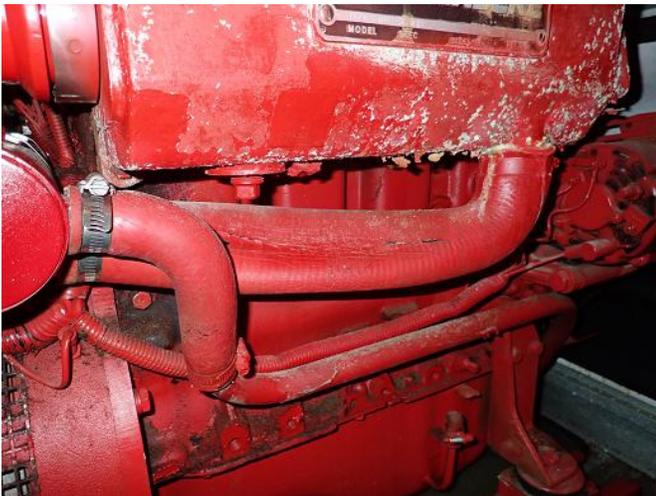
COOLING SYSTEM: Closed coolant and raw water exhaust type. System needs attention, collapsed hose and leaking noted.

Generator corrosion/collapsed hose

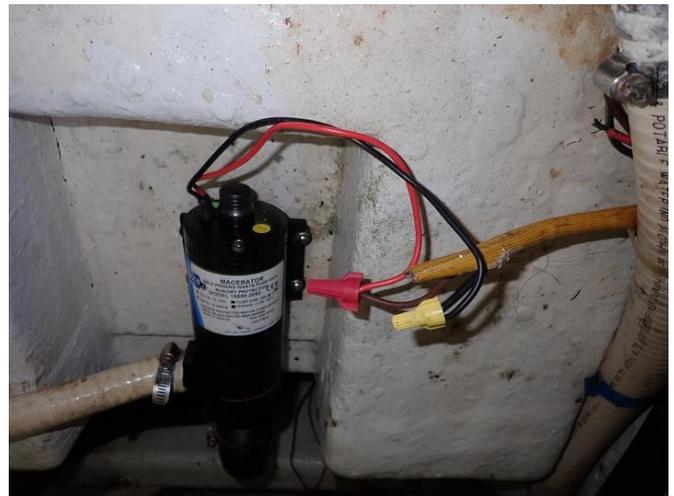
Holding tank vent hose was showing heavy age/jacket cracks. White sanitation hose at the tank top was showing staining/salt permeation type. Wire nuts noted in the wiring for the macerator pump.

Wire nuts for macerator

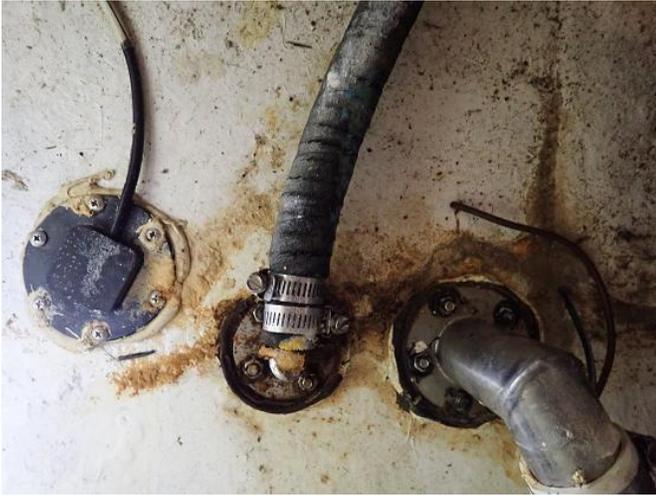
Holding tank vent hose age/jacket cracks

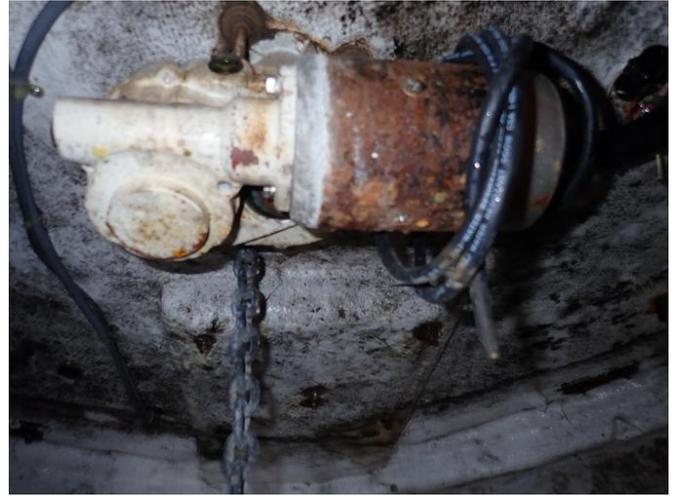
Windlass motor housing was showing heavy corrosion.

Windlass motor, heavy corrosion

May want to clean and paint to protect and prevent further corrosion.

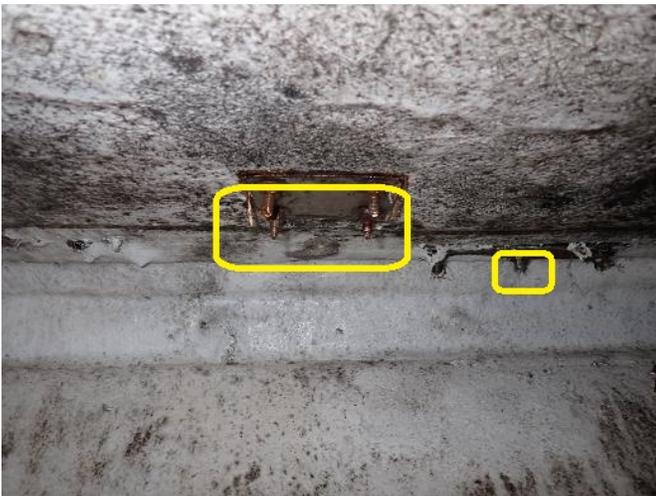
Water dripping off deck hardware, inside chain locker

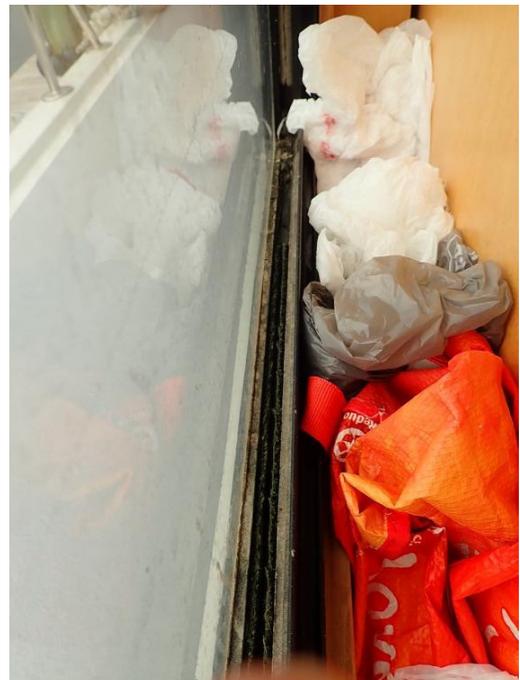
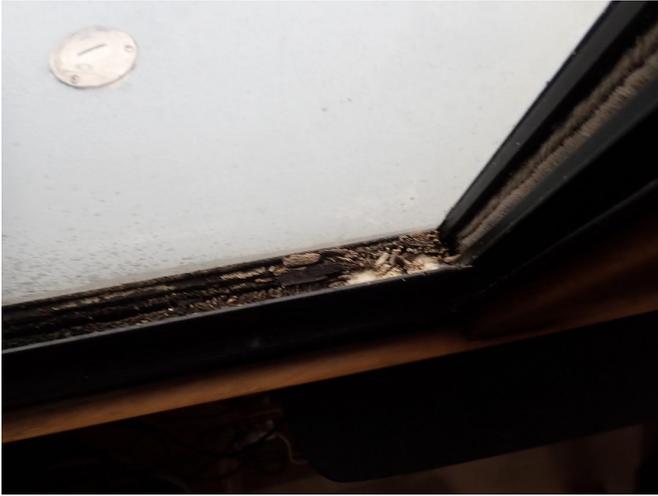
Side window felt sliders were deteriorating, drainage was poor in side windows due to this.

Felt track deterioration, slider windows

Felt tracks deterioration, slider windows
