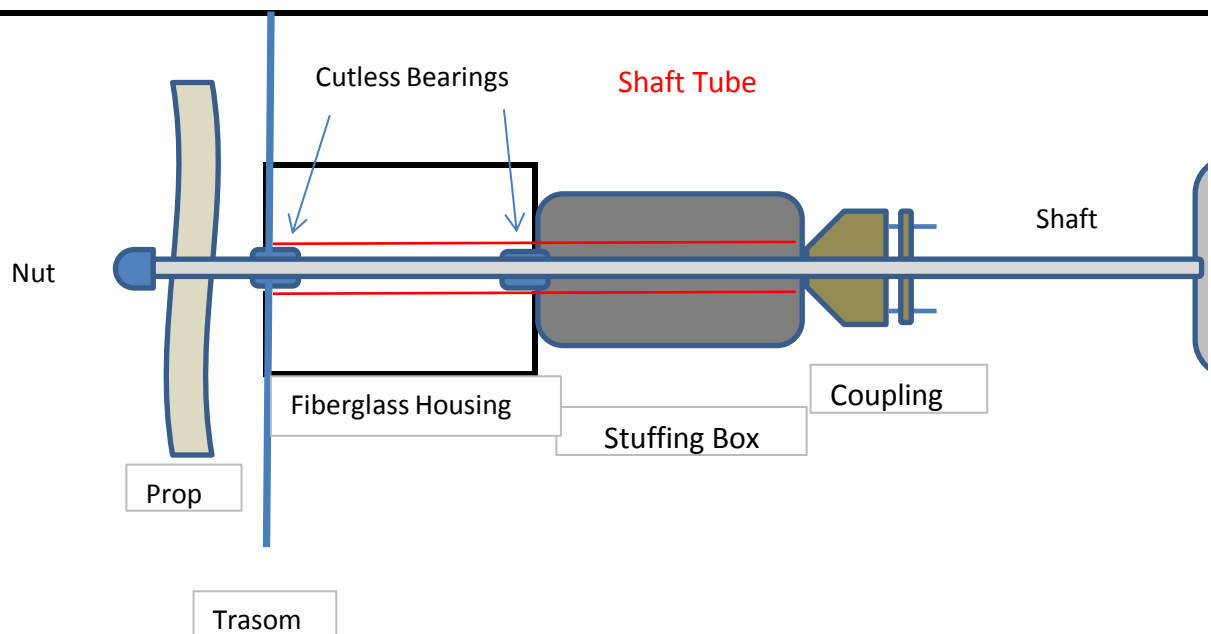
Water flowing through cutless bearings but not reaching coupling even with 50% of packing removed

Theory is brass coupling is so tight inside stuffing box then when shaft is turning and temperatures inc

and nuts loose.

crease not enough water is passing over shaft

Plan is to remove brass coupling and machining the IML or inside about 1/64"
