## **Mainship Hull Paint Info & Hull Repair**

My summary based on the Yahoo Mainship and Trawler Forum member inputs & post searching.

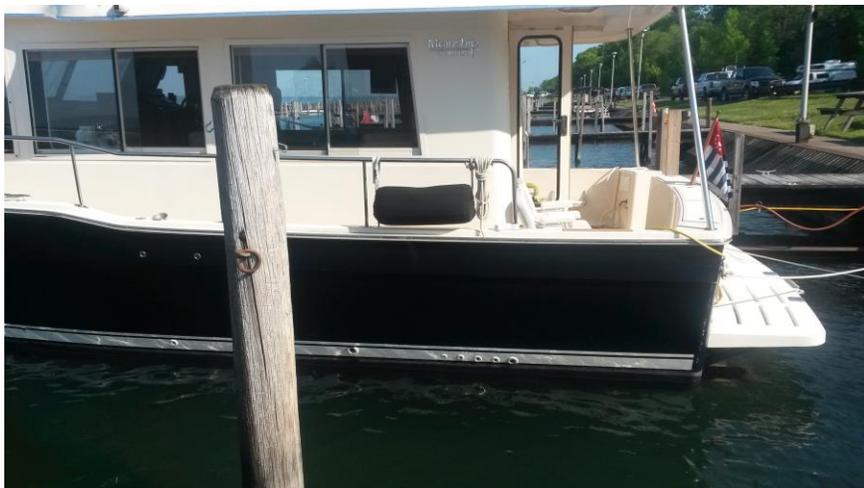
The repair I had to make was on the port side / aft and the crack in the gelcoat was the area just above where the bulkhead between the engine room and gennie (lazarette) meets the lower hull. The bulkhead ends below the side decks and creates a stress concentration point immediately above the attachment point when / if the rub rail above is flexed. The fix entailed reinforcing the inside of the hull around the bulkhead joint to spread the stress and to repair and repaint the outside of the hull.

The repaired area is below the fender approx. half way between waterline and rub rail

The outside of the hull was ground out in the area of the cracks and new glass mat & resin was applied in increasing width layers until the area was nearly flush. Final filling & fairing was done w/ chopped glass reinforced filler. Auto body filler worked well (above the waterline) and provided a fast set and easy finishing.

The repaired area was primed with the Awlgrip epoxy primer and topcoated with Awlcraft 2000 to match the original hull paint. The color match was excellent and with an experienced spray painter / masking job very little overspray was visible. I let the Awlcraft cure for the season and plan to buff lightly during spring commissioning.

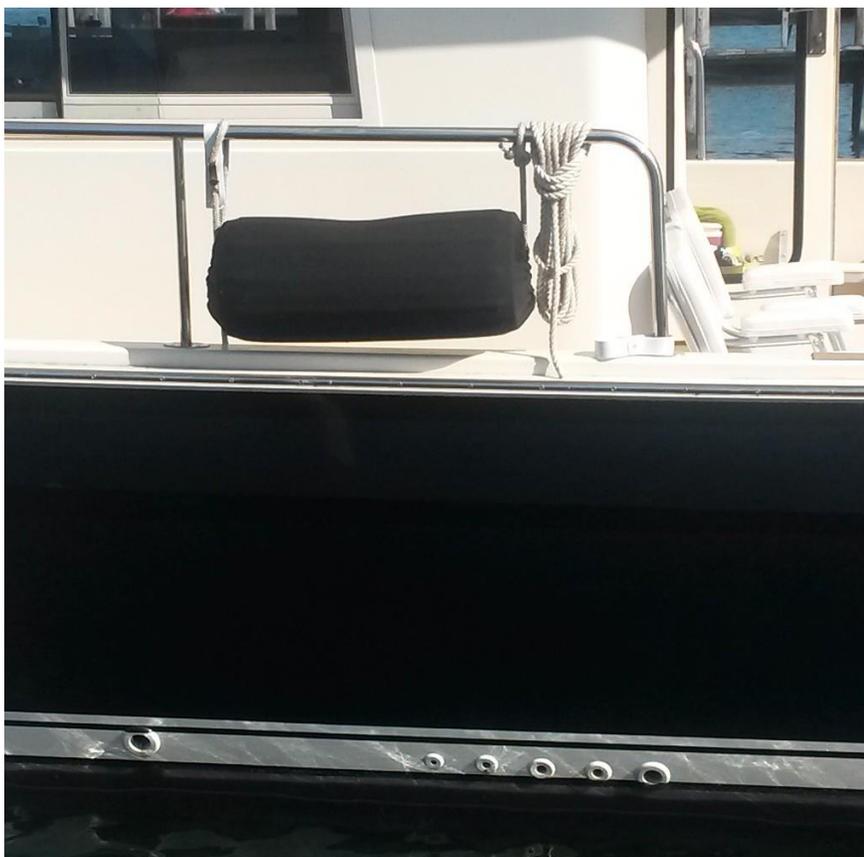
As you can see the color match was excellent – and trust me the overspray haze was minimal
