FAULT TRACING GUIDELINE FOR MODEL 250V AND 275V

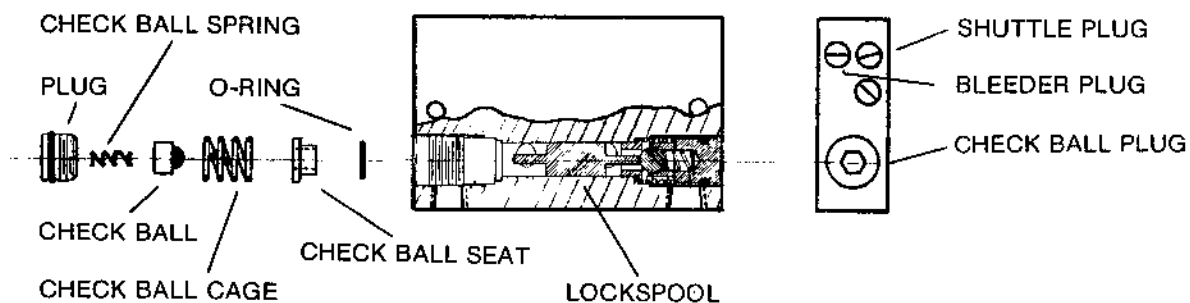
A — UNIFLOW VALVE LOCKSPOOL AND CHECKBALL ASSEMBLY

- CAUSE - dirt in Uniflow check valves.
- SOLUTION - remove check valve plugs. (See Sketch A). These are the large black plugs with a hex key hole on the side of the Uniflow Valve mounted above the cylinder. Clean ball seats and balls and re-assemble. NOTE: Be prepared to lose a certain amount of oil during this procedure. Have a small can available. Refill system when check balls have been re-assembled.

Note - Check ball seat and o-ring are retained with retaining ring and should not be removed unless ball seat or lockspool is defective.

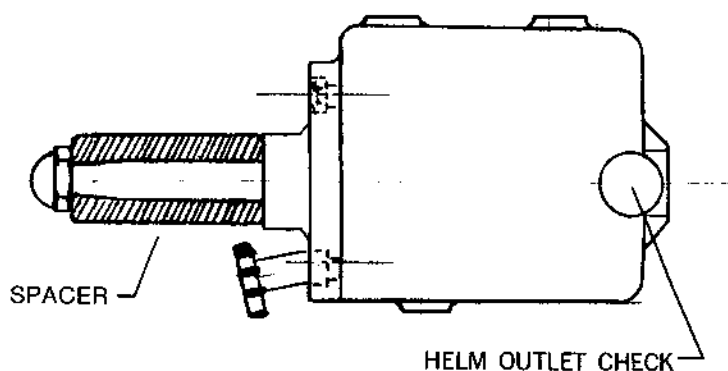
B — SPACER ON HELM SHAFT

- 8. FAULT** - **ONE HELM UNIT IN SYSTEM IS VERY BUMPY AND REQUIRES TOO MANY TURNS FROM HARD OVER TO HARD OVER.**
- CAUSE - dirt in inlet check of helm pump.

- SOLUTION - remove steering wheel. Remove helm from dash or console, and drain helm of fluid. Install spacers on helm shaft to take slack between helm shaft nut and front cover. (See Sketch B). Loosen the four front cover bolts and carefully remove shaft and rotor assembly. (See Sketch C). Bottom side of rotor will reveal 5 or 7 inlet balls. One of these will be found held open by some contamination. Clean and re-assemble. CAUTION: Use care when re-assembling helm unit, making certain that 'O' ring is not pinched, etc.

Note — Any combination of washers, bushings etc. can be used. Make certain that spacer is held firmly in place by helm shaft nut, before dismantling unit.
