An overview of replacing the fuel tanks in a 1984 Island Gypsy 36 Europa

A retrospective from May 2023

David Bagby

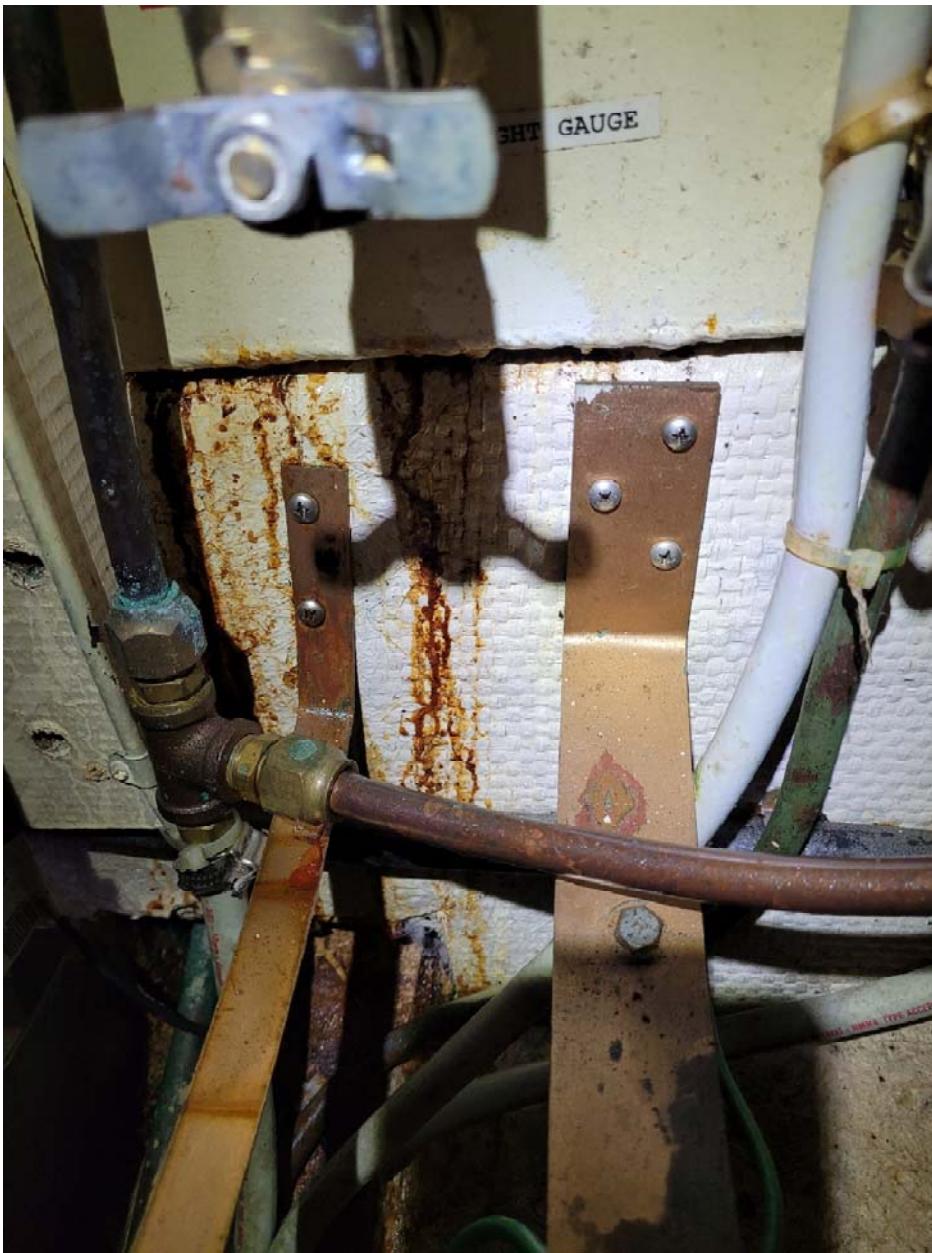
This story starts in fall 2020, when I first noticed this weeping from between the Stb fuel tank and the stringer it sat on...

The discovery caused chills along my spine...

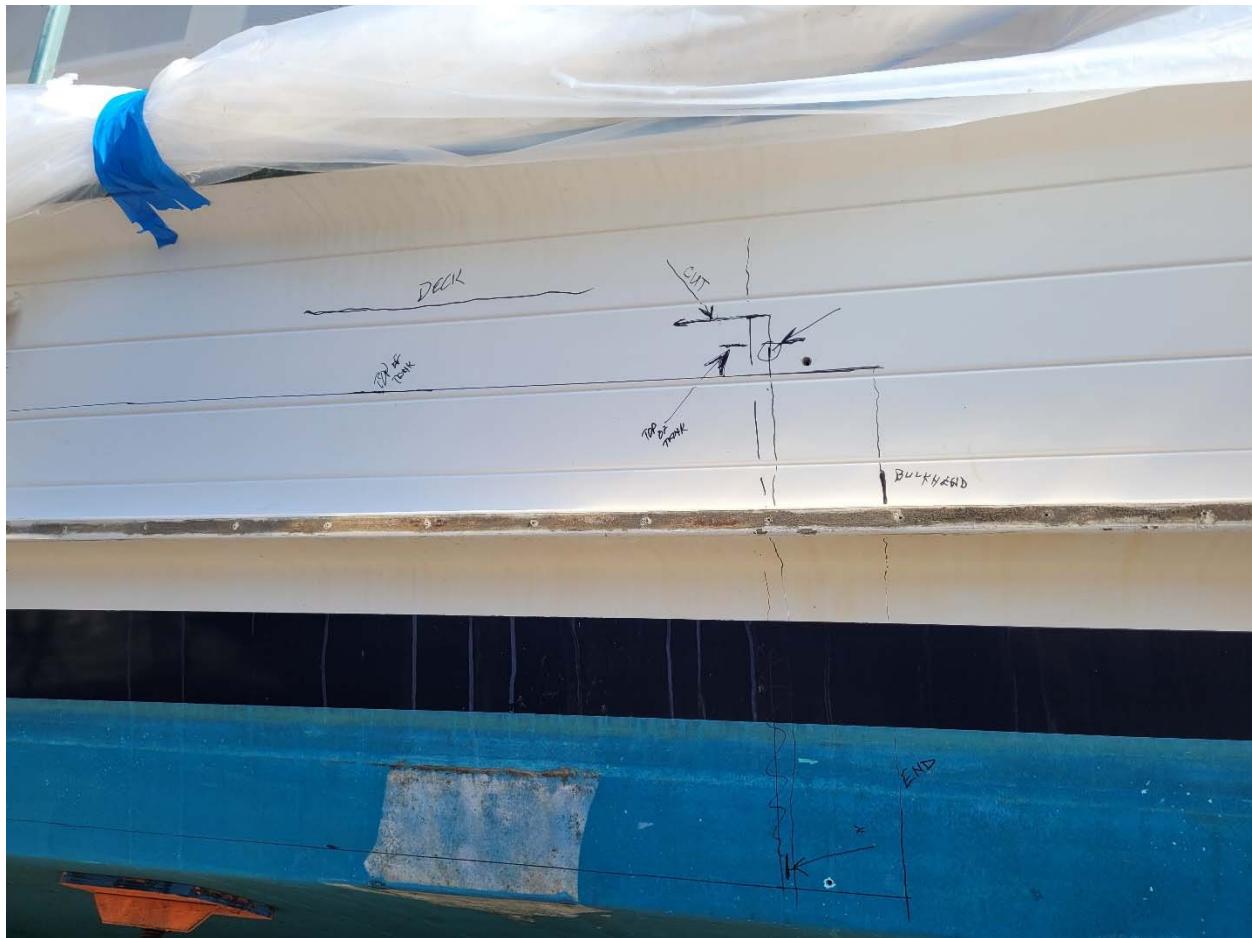
After hauling out, it was time to locate the tanks precisely. This involved careful measurement, and judicious drilling of location reference holes from inside. This transfers the tank location to the outside of the hull.

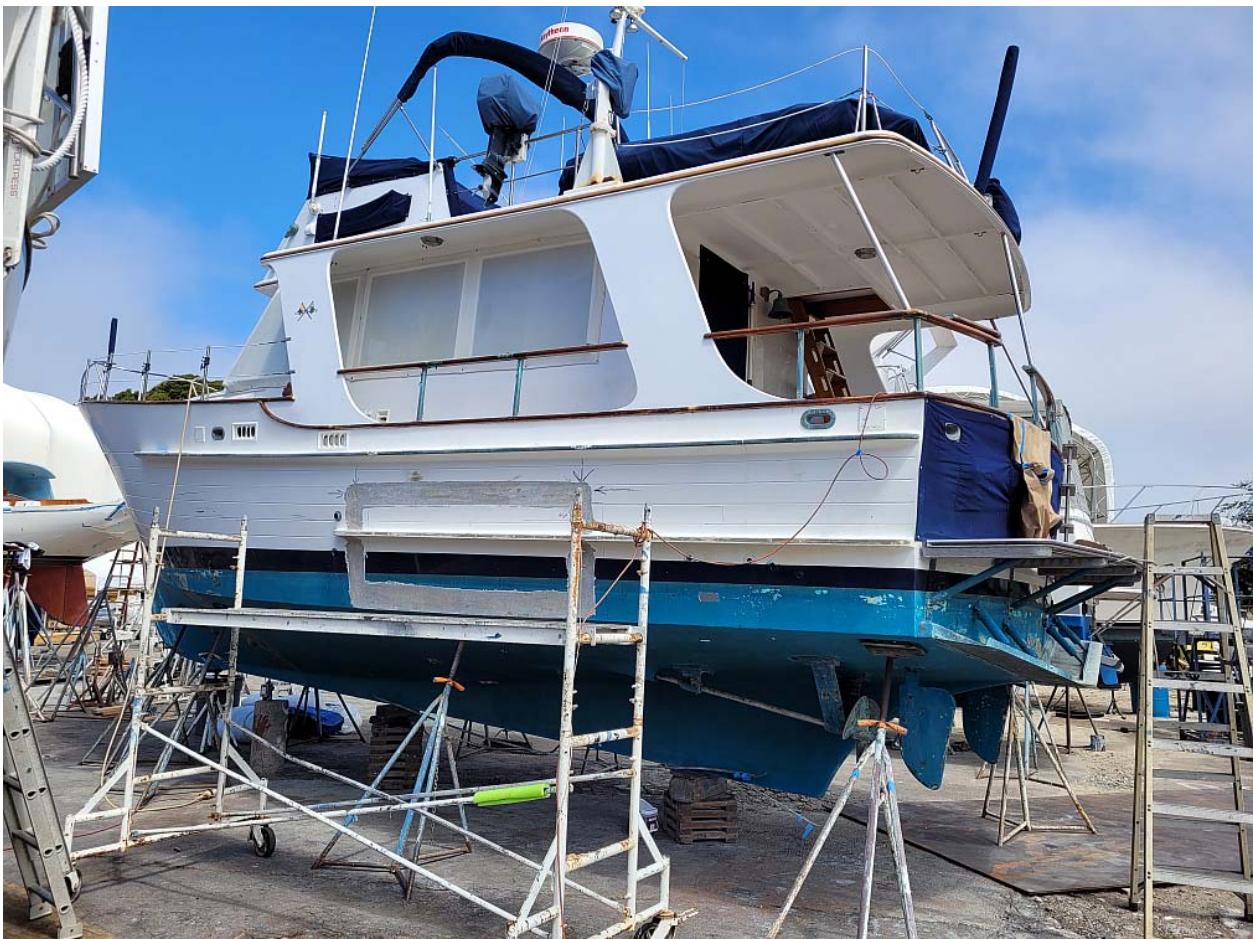
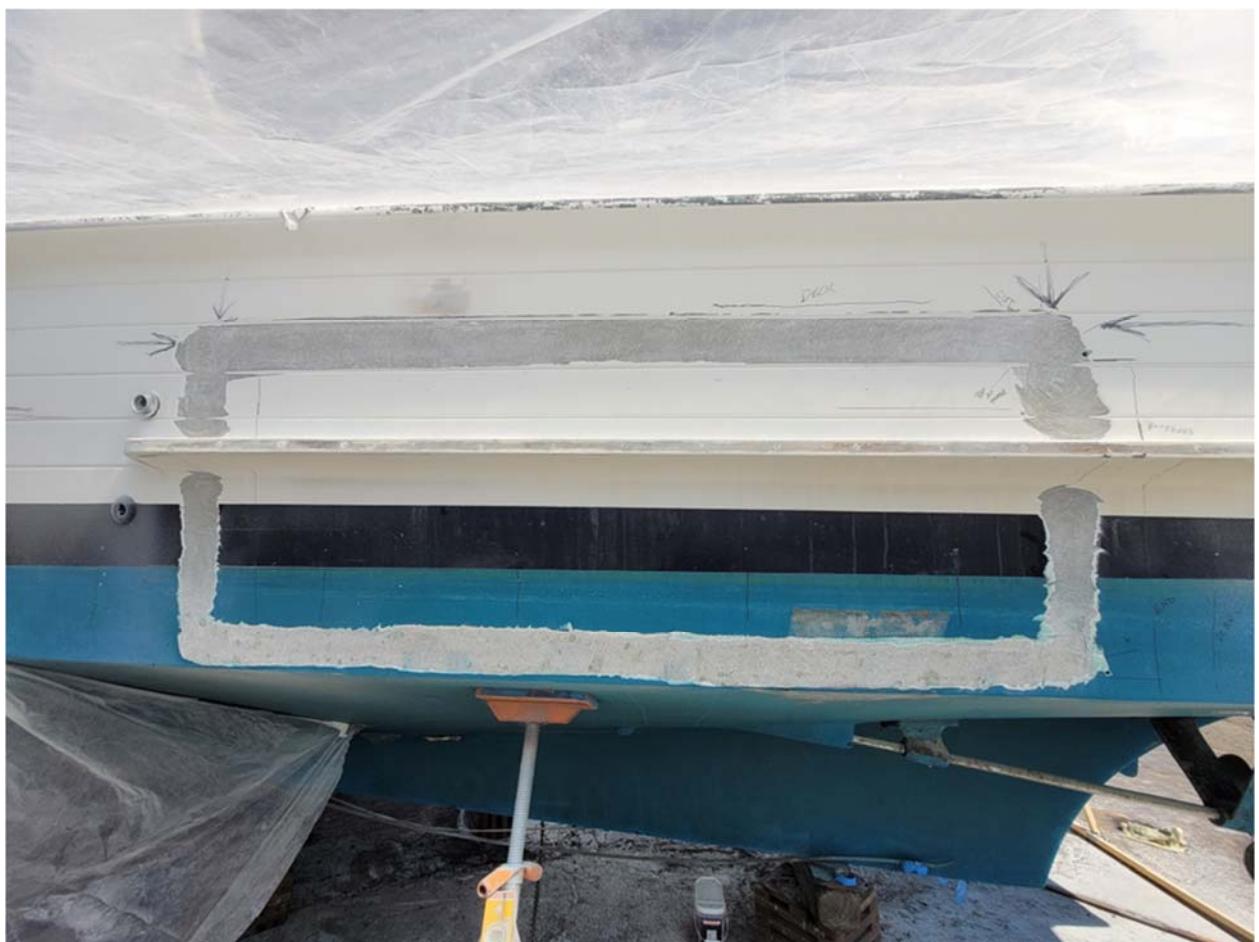
Next you prepare to remove the patch area to get to the tanks. This starts with grinding a wide (compared to the cut line) shallow Vee, centered on where the cut will eventually be, into the hull. The wide Vee becomes the area that provides the scarf ratio for later re-lamination.

Here is the port side before plug removal:

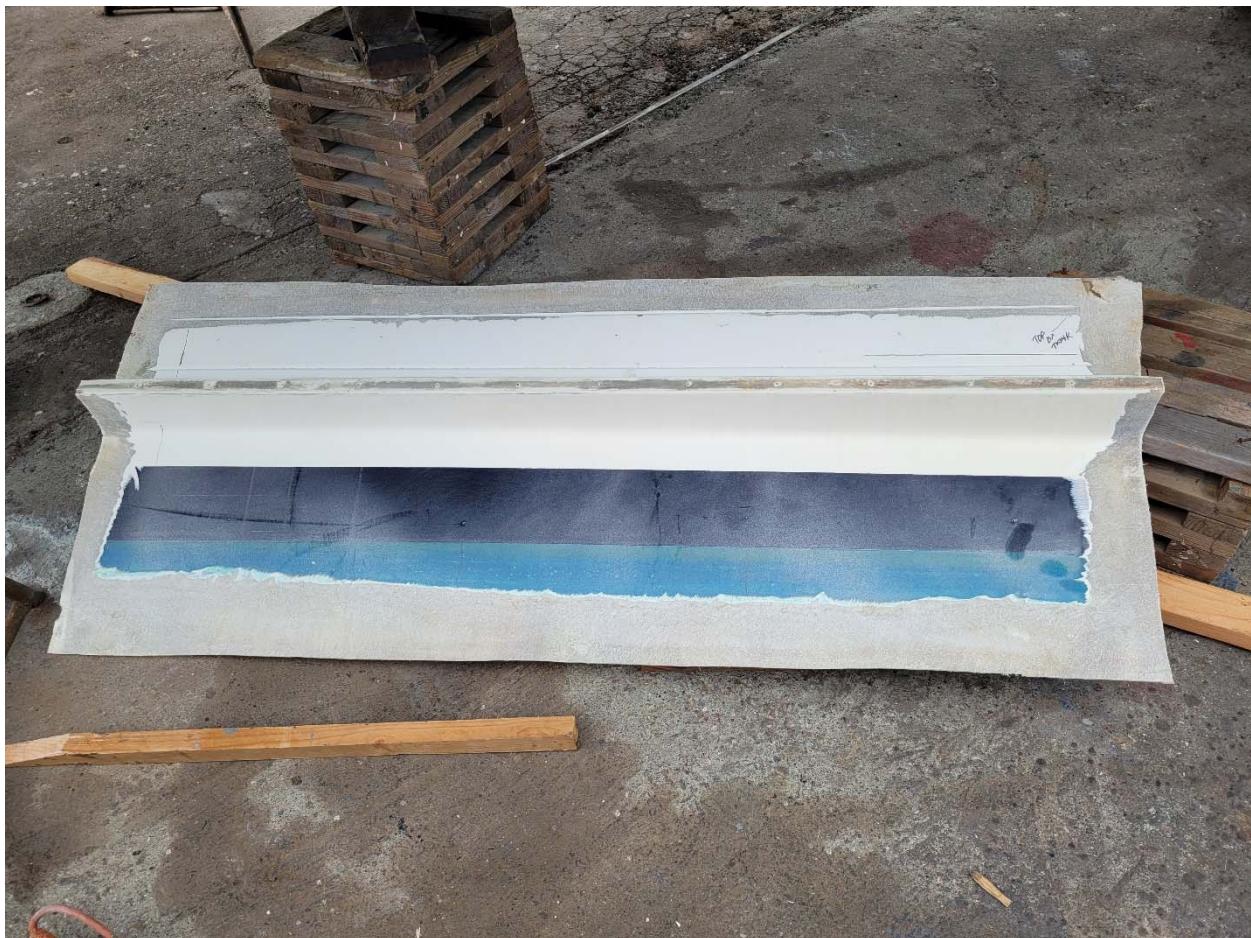
Here's the section that was removed:

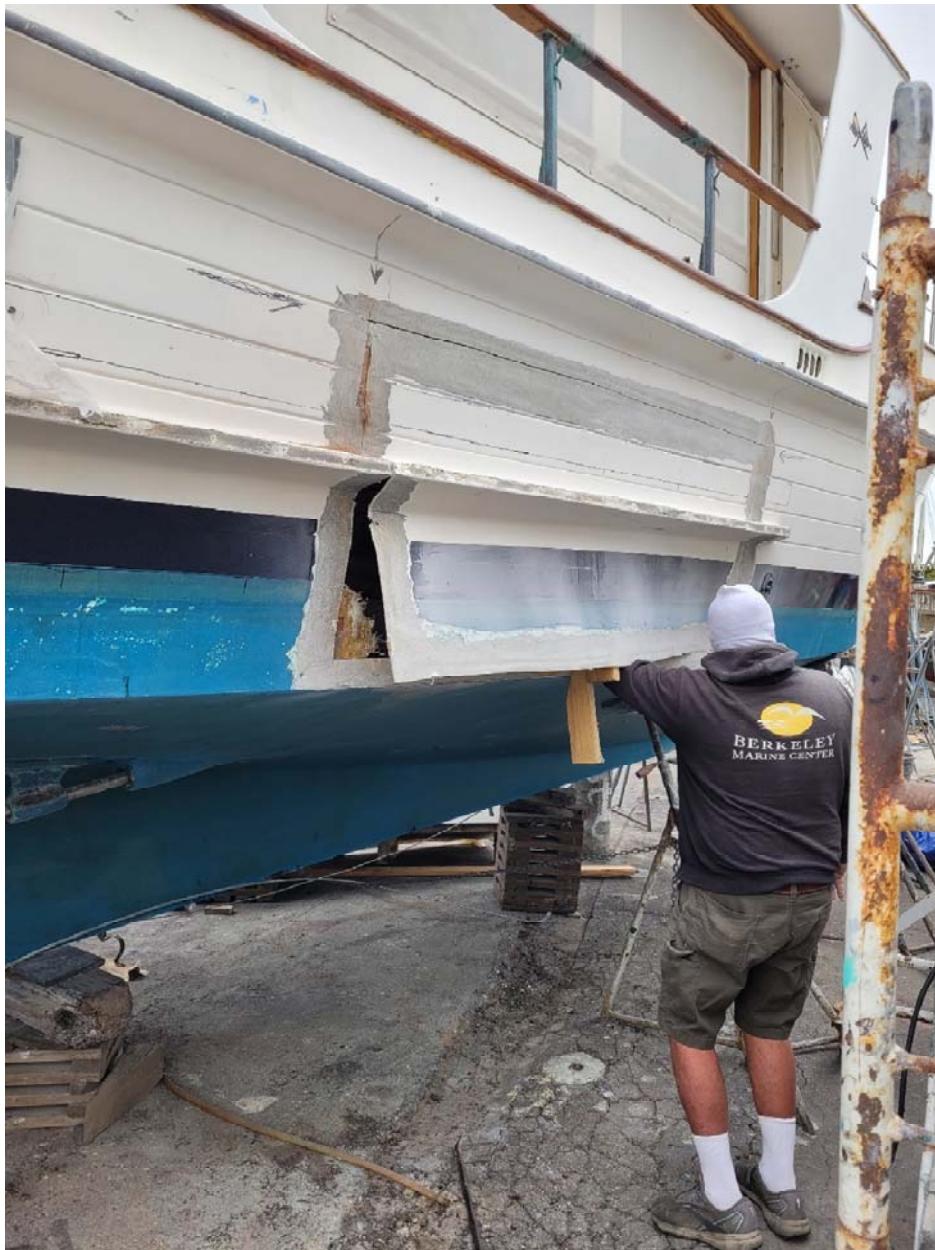
A blend of brute force grunt work and finesse is involved in removing the plugs (stb side pic) due to internal bracing etc. Note: secondary FRP bonds are way easier to break than one might expect.

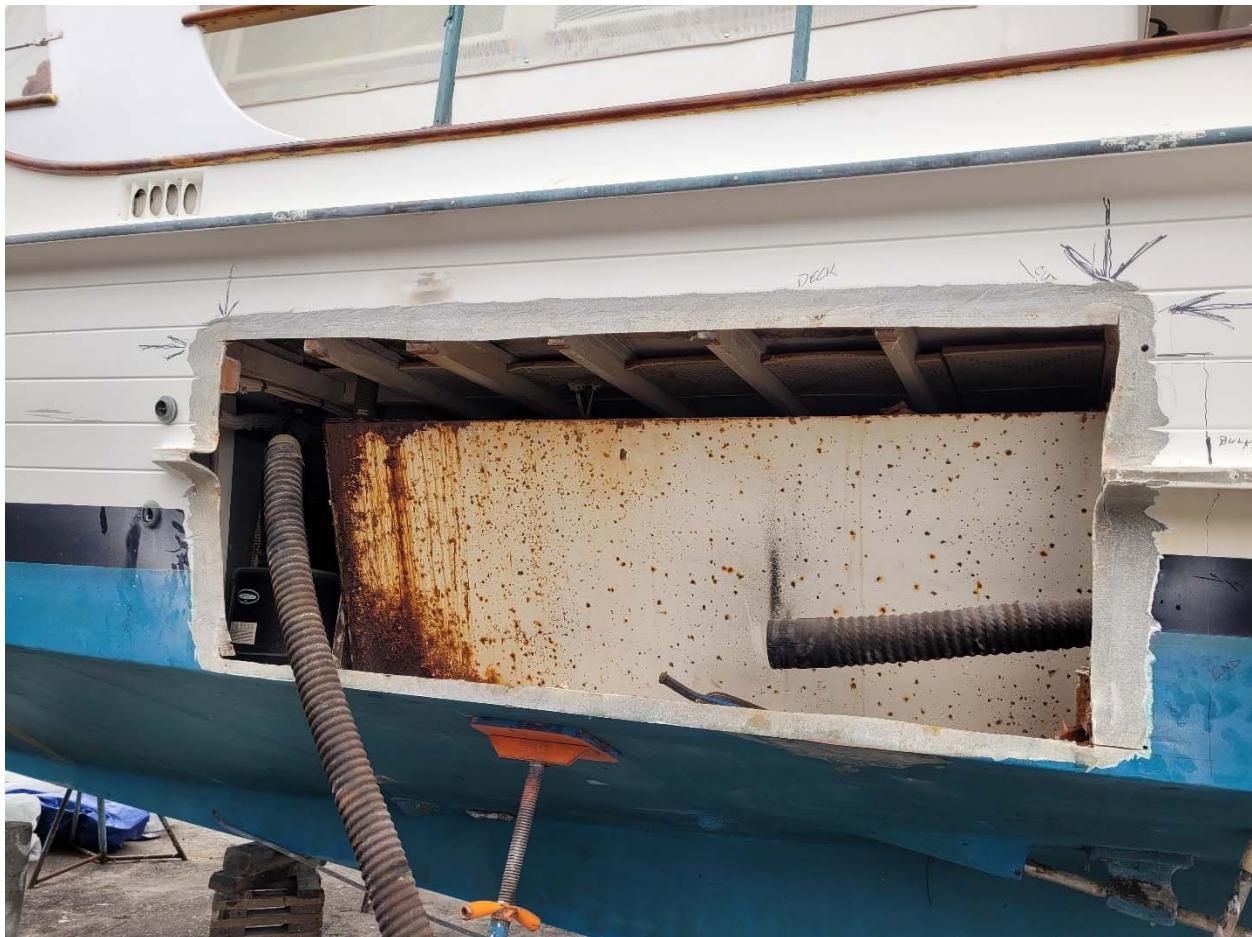
The access hole made seeing the core problem easy:

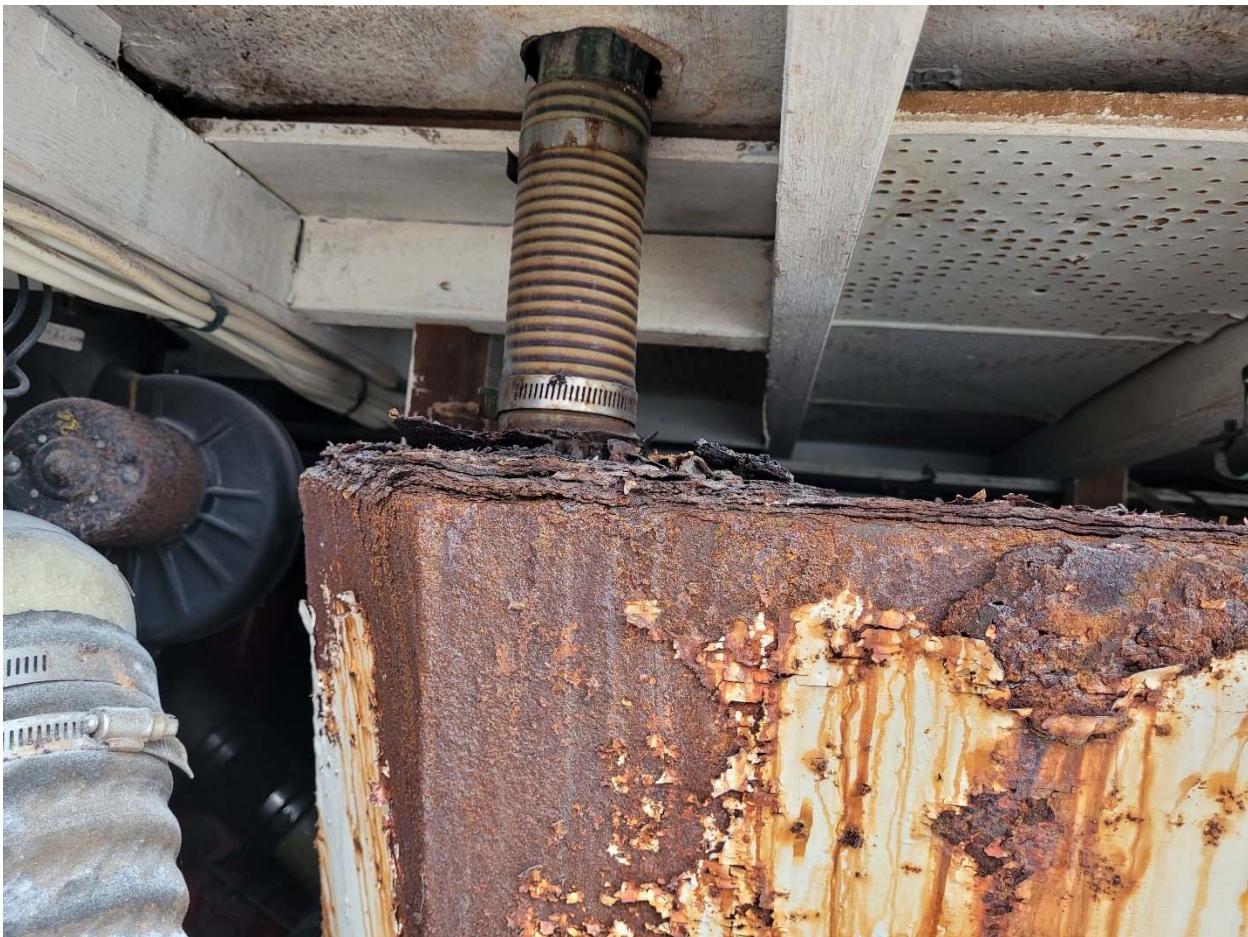
Combine 38 years, a suspected past leak at the deck fill fitting, steel tanks, and this is the result:

Moral of the story? That little bit of caulking around deck fills is really important! It's much easier to redo it periodically than to replace tanks! You can bet we re-bedded all the deck (fuel and water) fills.

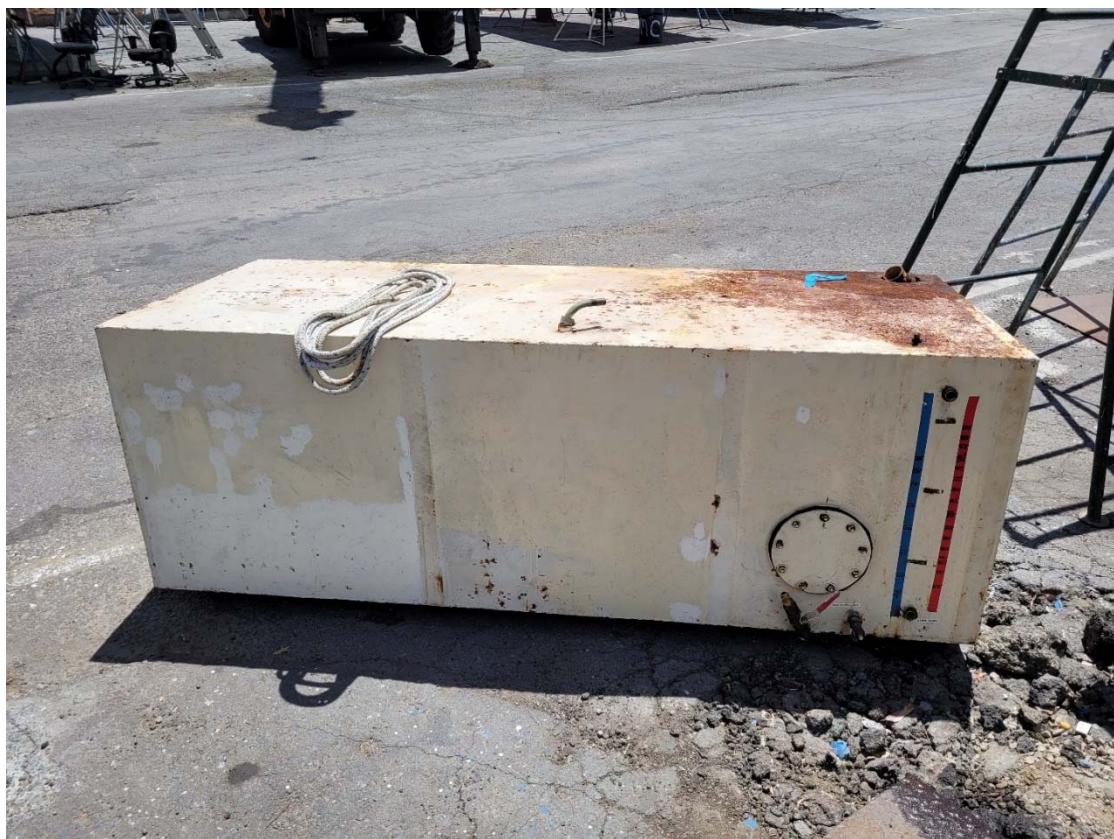
The tanks had reached the end of their life – they were terminated with extreme prejudice.

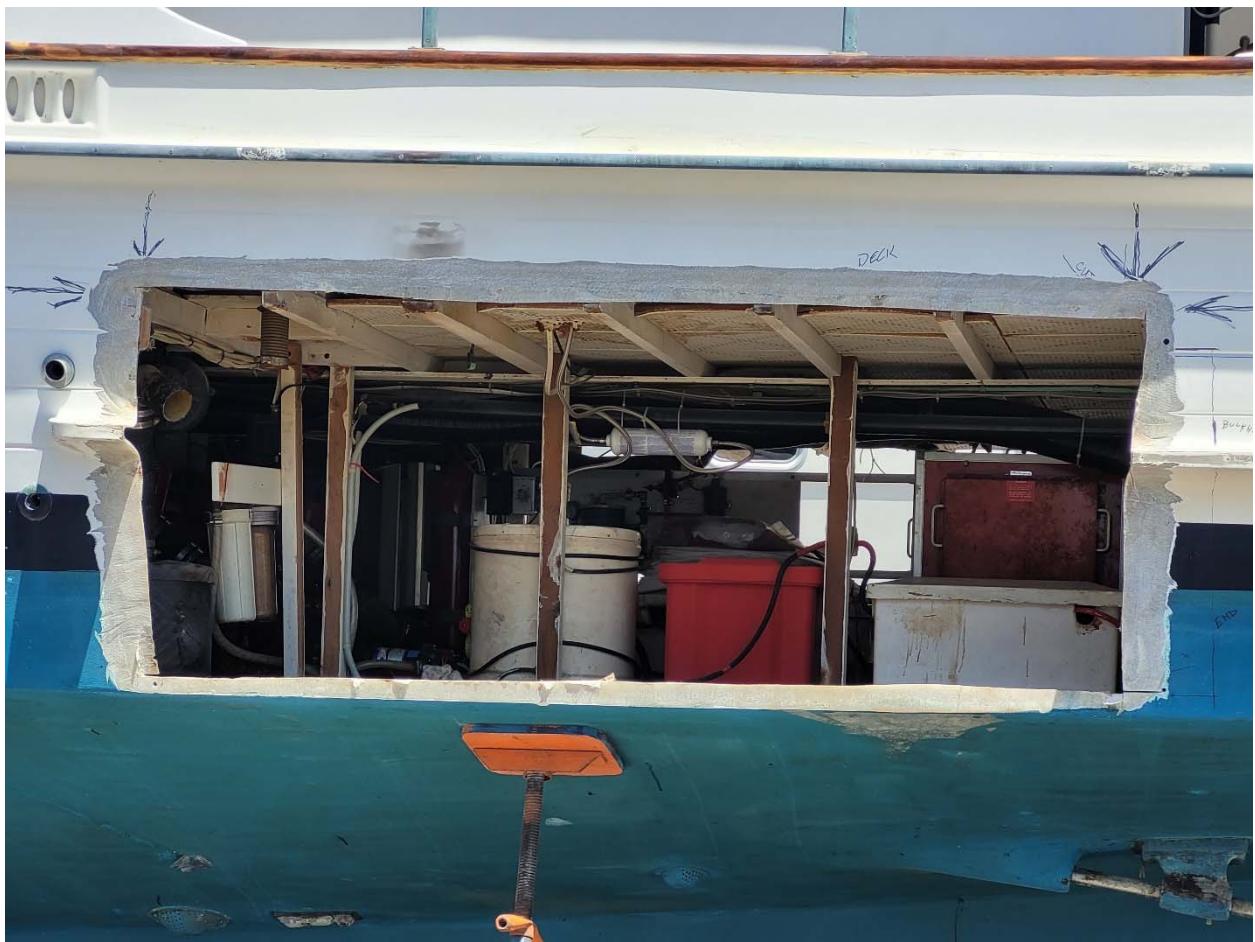
With the old tanks out, you get some uncommon views.... I could literally stand on one side and see out through the opposite side of the hull.

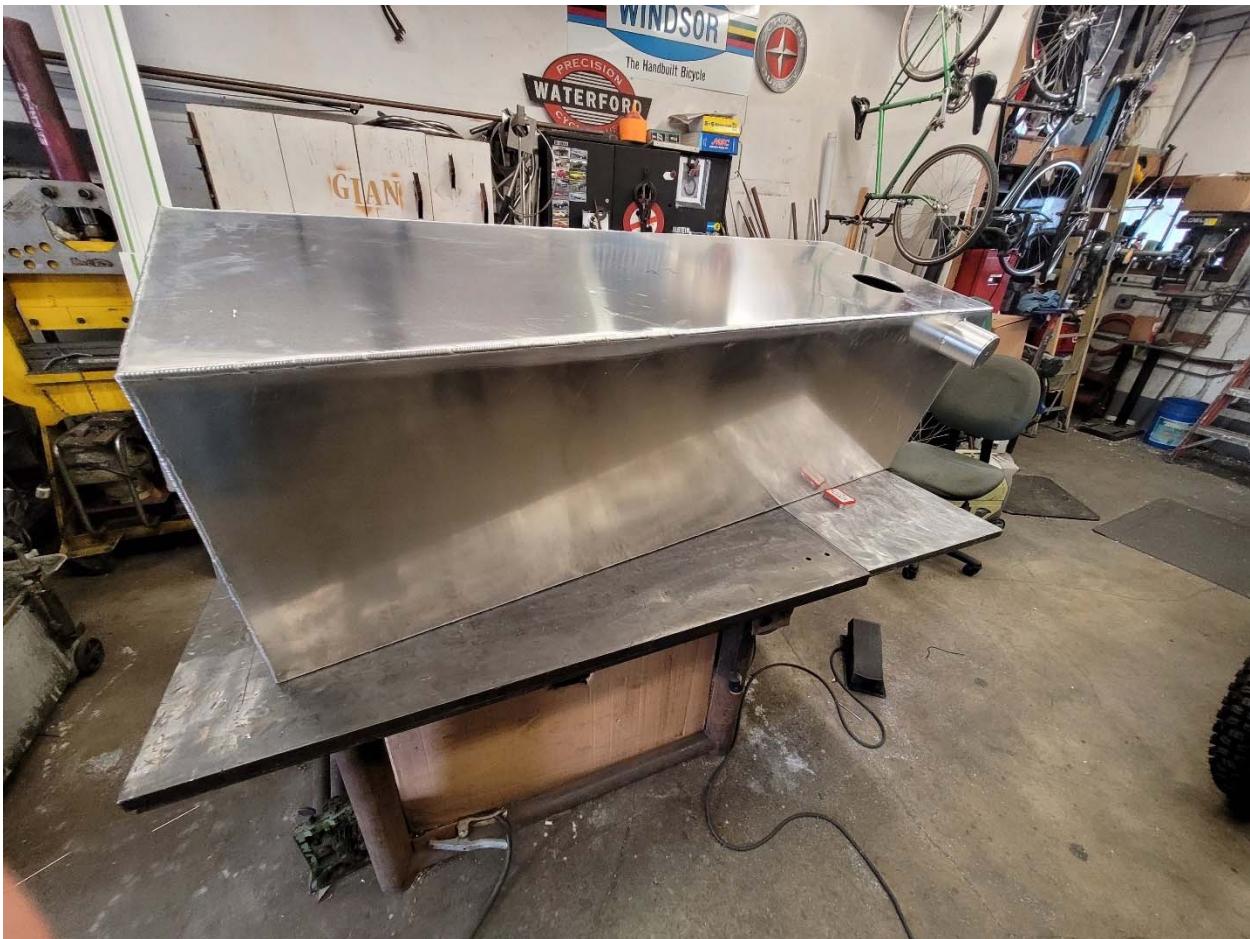
The replacement tanks are works of art:

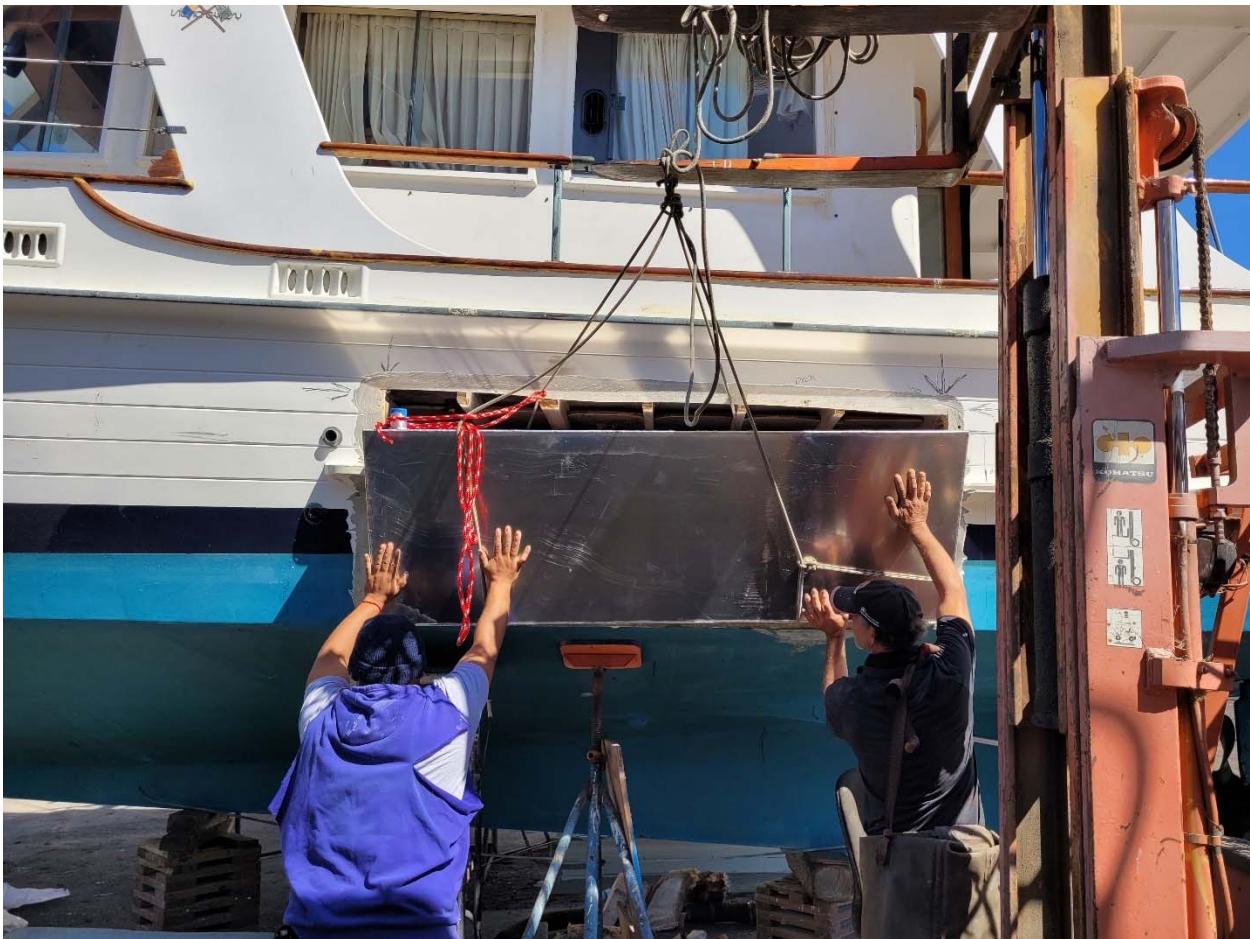
Here's the test fitting of the port tank:

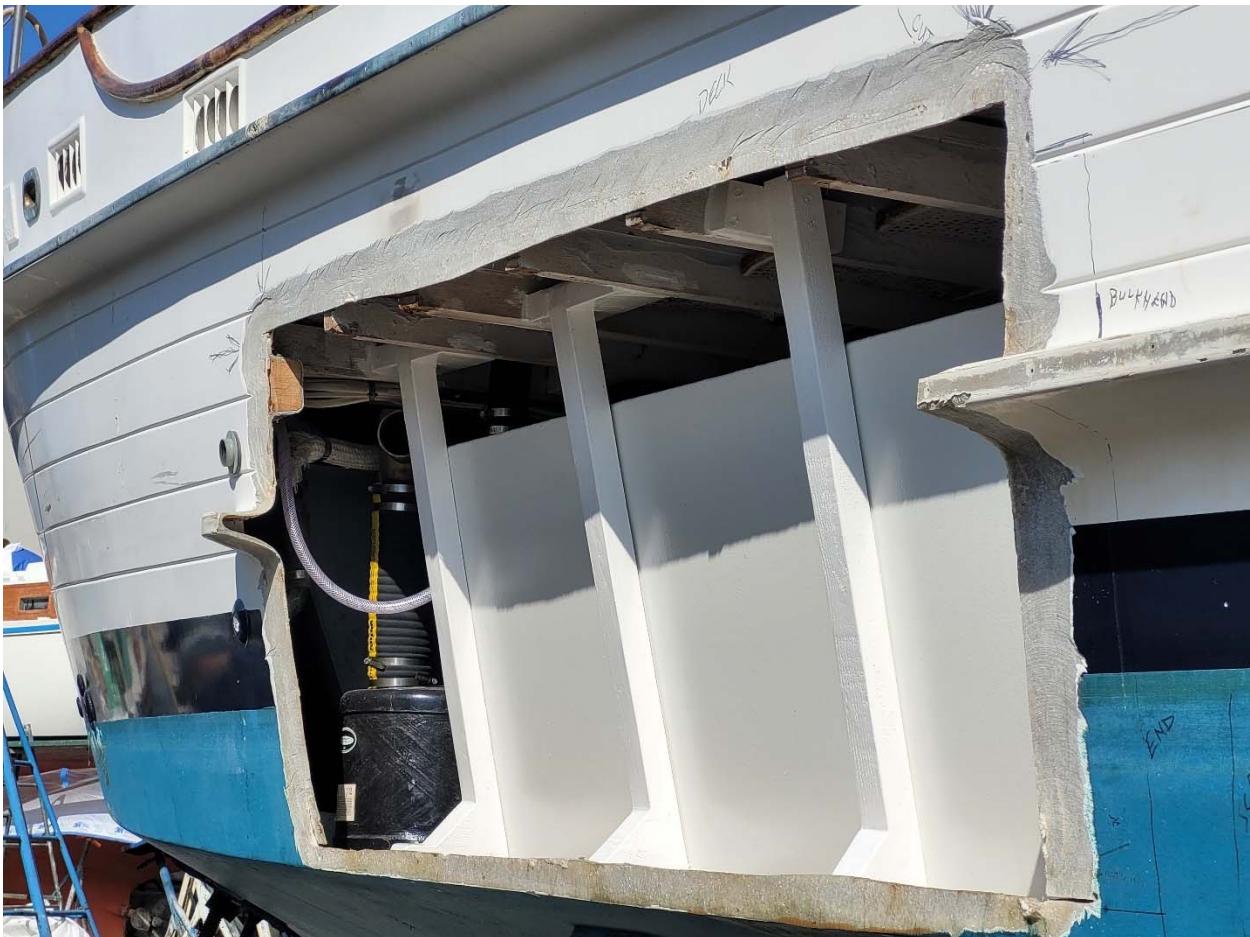
The tanks were then epoxy coated, installed and secured:

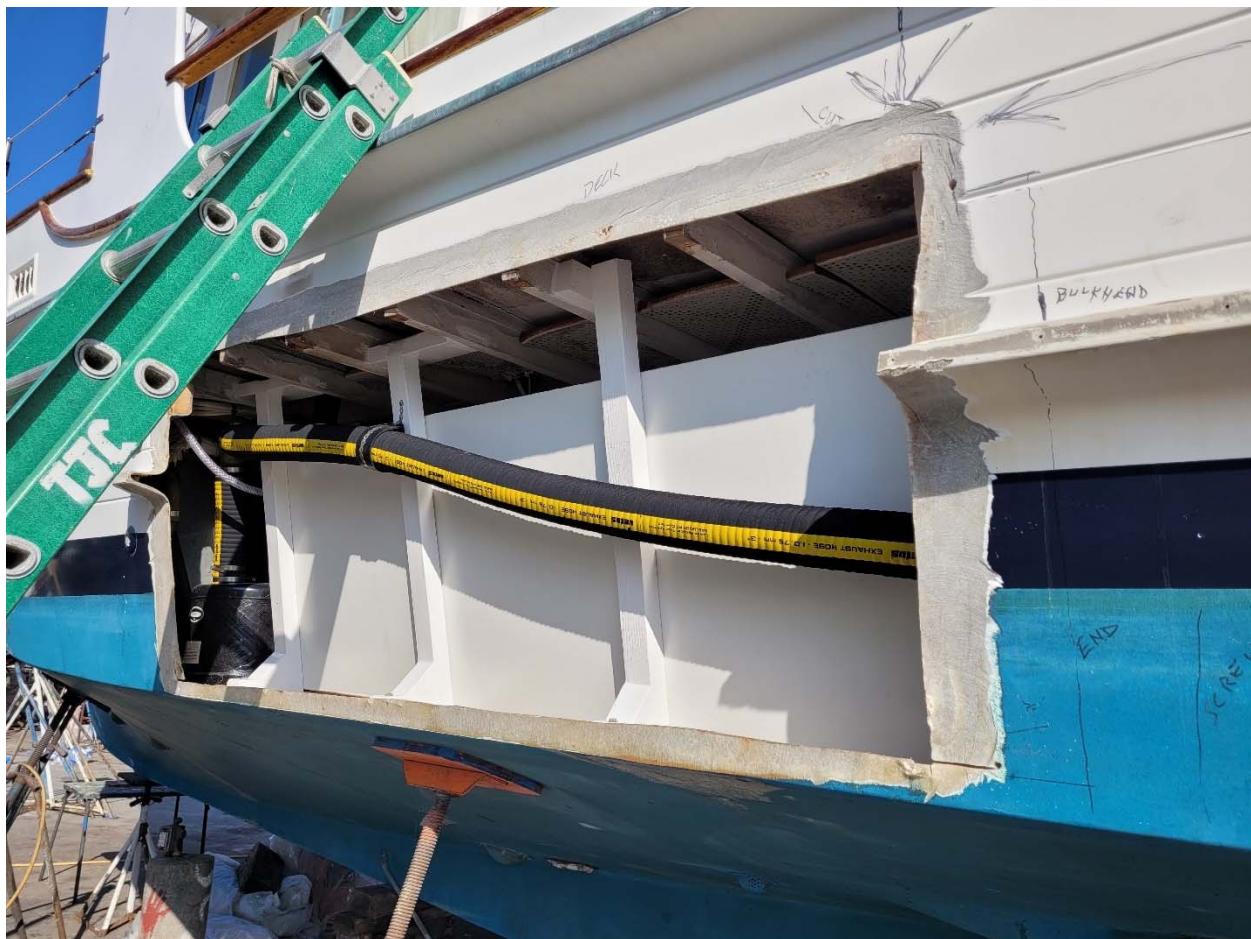
Lots of other major maintenance tasks got done “while we’re here”. Ex: new exhaust hose runs to the transom.

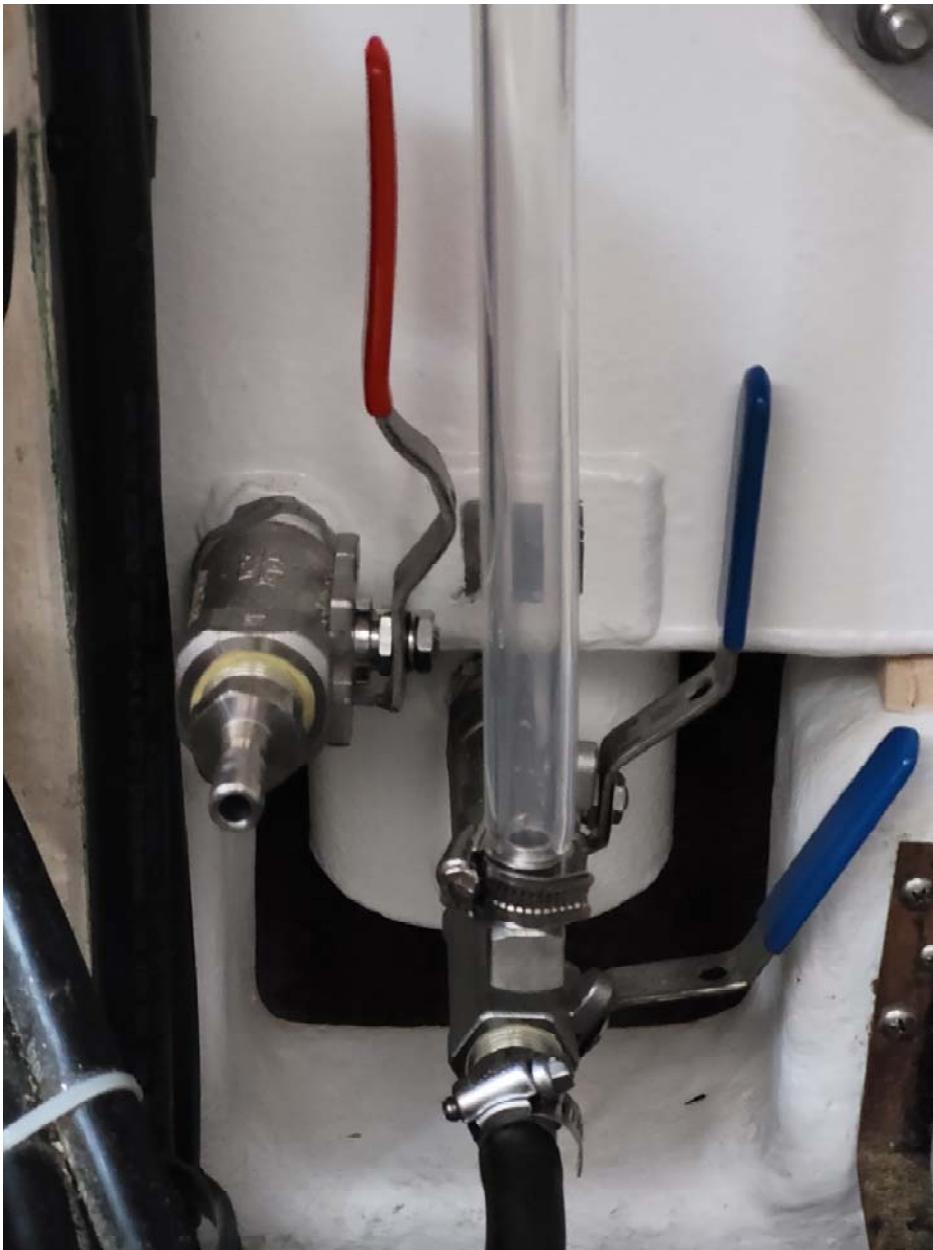
I also improved the tank connections. Calypso has a fuel polish system I added to the original fuel plumbing. She now has independent polish system draw and return fittings in the new tanks. The old sight gauges did not let you see the level at the top and bottom of the old tanks. The top is not much concern... but the bottom is where you really want to know the fuel level. A sump was added to the new tanks to make drawing for the polish system the lowest point, and the sight gage fitting is there too, so the bottom of the sight tube starts below the bottom of the tank.

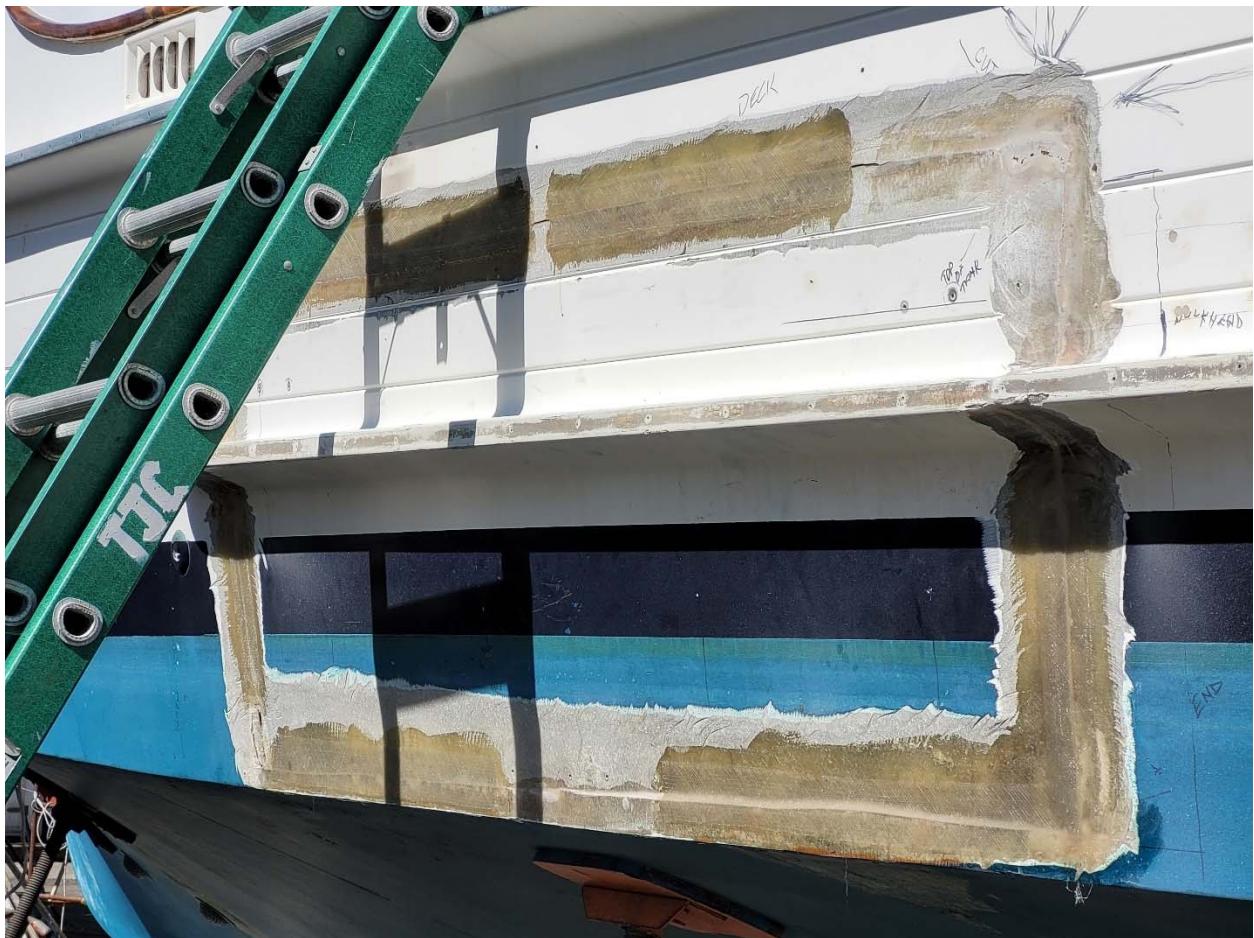
There was lots of prep work to replace the plugs – added internal bracing to hull stringers that had to be cut to remove the plugs. The liberal use of a 2000 psi adhesive bonds the plugs to the new supports (located between the tanks and the hull). Then it's ready for re-lamination.

Here is the port plug initially replaced in the hull.

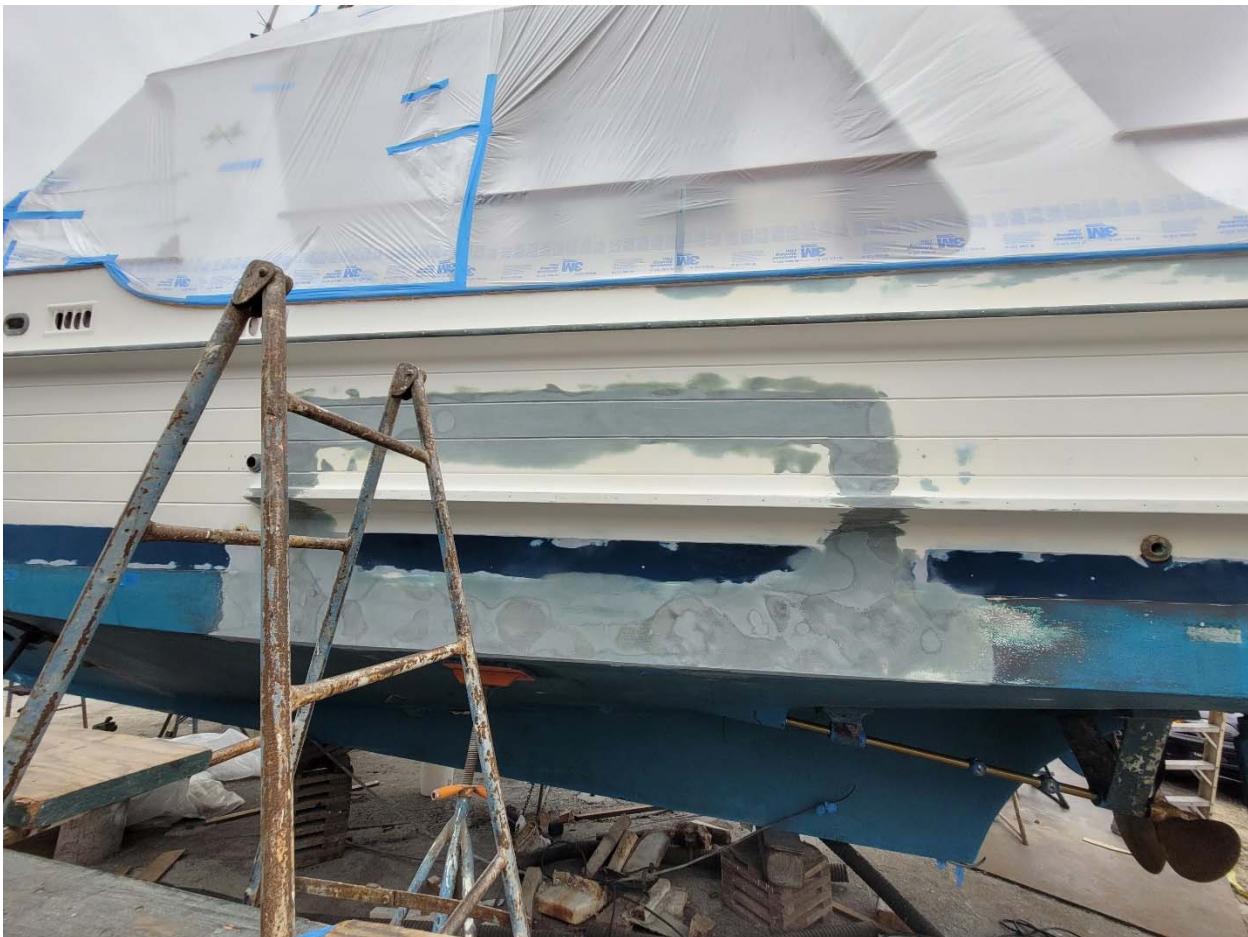
Then re-lamination is accomplished. Afterward fairing and prep for painting gets done:

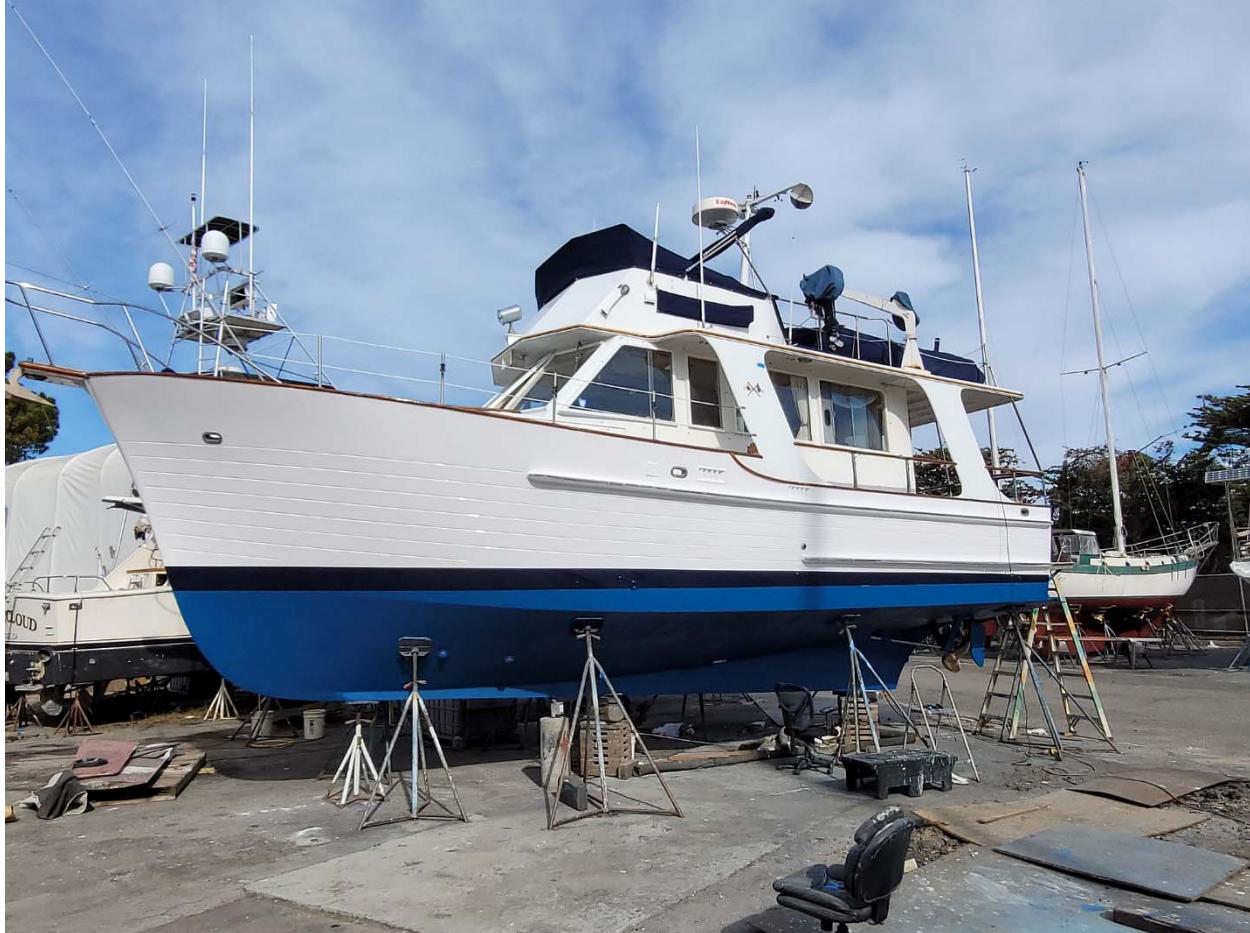
Calypso was relaunched Nov 28th, 2022. Here's a pic of her just before launch:
